DS Murphy Inspections  
Suwannee, GA 30024  
678 573 6005

# Inspection Report

**6105 Lynwood Dr  
Forest Park, Ga 30279**

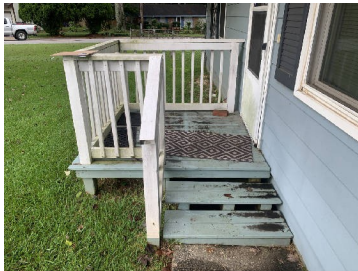
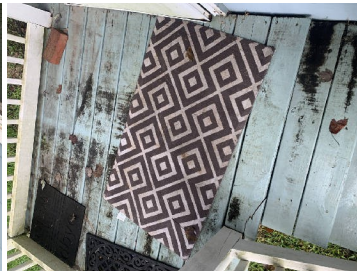
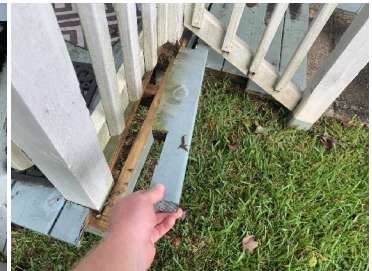
Porch: Wood~ One of the front porch deck boards was cracked and not secured. Recommend remediation.

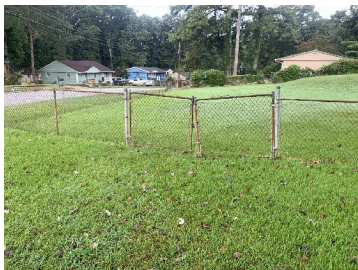
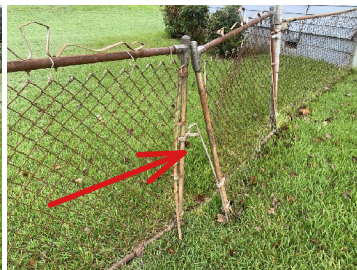
Fences: Chain link~ The gate at the left side of the house was broken at the time of the inspection. Remediation recommended.

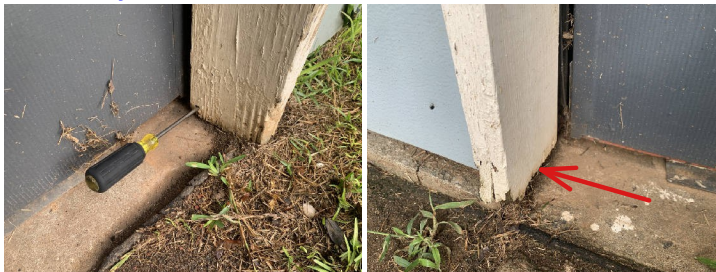
Trim: Wood~ Wood rot noted at the garage door trim. Recommend repair or replace as necessary.

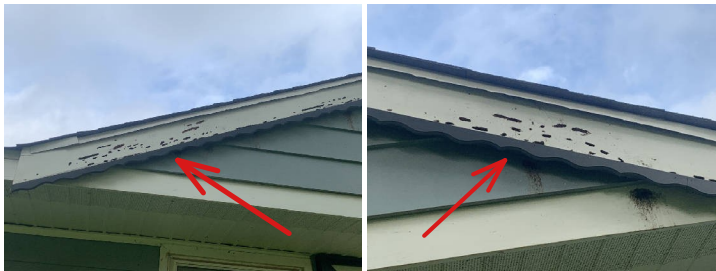
Fascia: Wood~ Wood rot noted at various areas of the fascia from what appears to be carpenter bee activity. Recommend repair or replace as necessary.

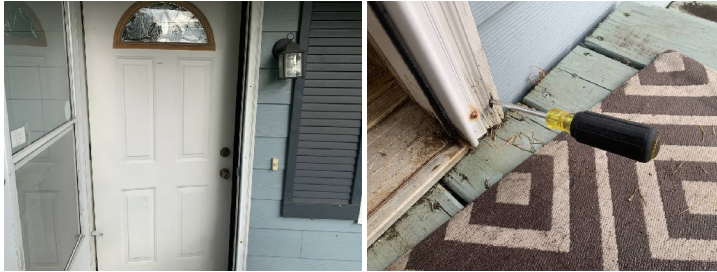
Entry Doors: Wood~ wood rot noted at the front door frame. Recommend repair or replace as necessary.

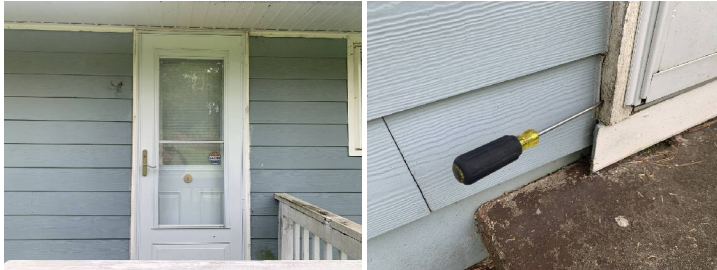
Entry Doors: Wood~ Wood rot noted at the rear door frame. Recommend repair or replace as necessary.

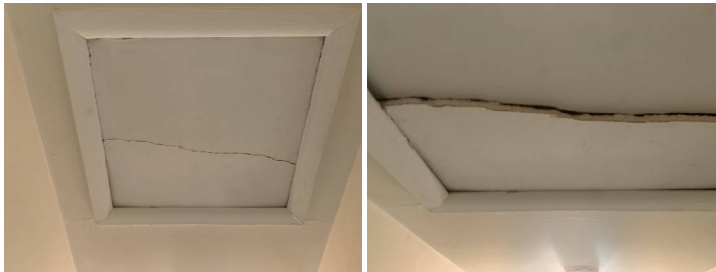
Attic Access: Scuttle~ The attic access door was broken in half at the time of the inspection. Recommend remediation as necessary.

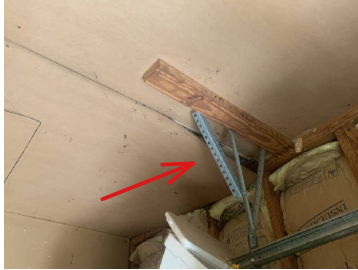
Ceiling: Drywall unfinished ~ Tape Coat of Drywall Compound Only~ Small section of the garage ceiling was falling at the time of the inspection. Remediation recommended.

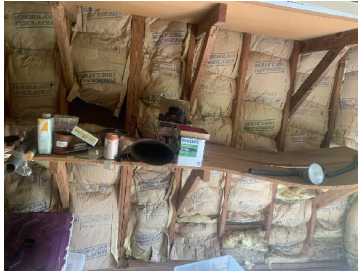
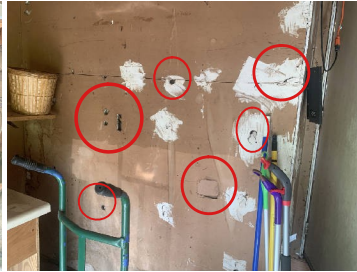
Walls: Exposed framing~ Various holes that require patchwork at the garage wall. Recommend remediation as necessary.

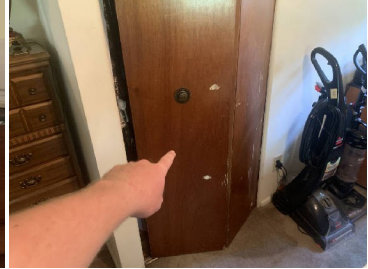
Doors: Hollow wood~ Mechanical room door had a hole in it and the other entry door to the mechanical room was off of the slider. Also the bedroom closet sliding door would not fully close. Recommend remediation as necessary.

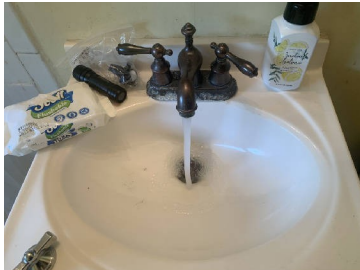
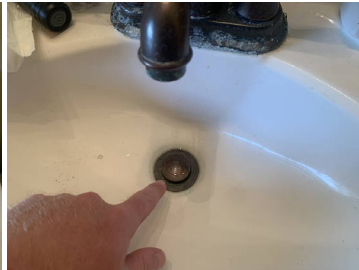
Bathroom Sink/Basin: Functioning with no leaks at the time of inspection~ **Drain stopper does not function properly. Recommend repair or replace as necessary.**

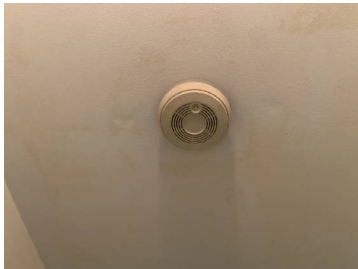
Smoke Detectors: Battery operated with light~ **Current standards recommend smoke detectors be installed any room with a fireplace, on all floors, and outside sleeping areas.**
