DS Murphy Inspections
Suwannee, GA 30024
678 573 6005

Inspection Report

**3144 Flamingo Drive
Atlanta, GA 30344**

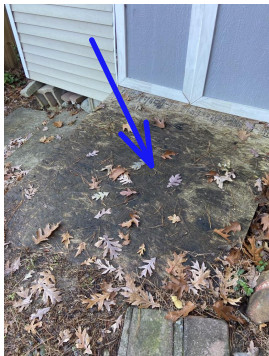
Minor Defect Walks: Wood~ OSB board installed for ramp leading up to the white outbuilding which material is not designed for outdoor use due to rotting.
Recommend replacing with pressure treated plywood.

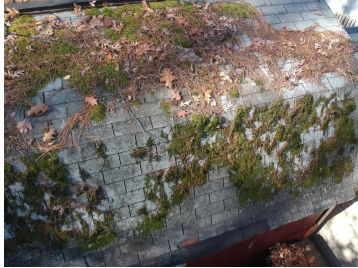
Roof: Asphalt shingle~ Heavy moss present on the shingles on the red outbuilding.
Recommend removal of moss to extend the service life of the shingles.

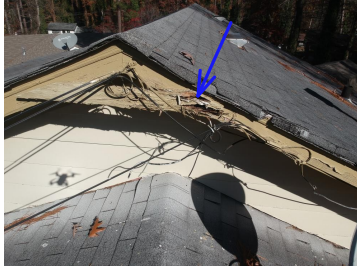
Trim: Wood~ Wood rot present on wood trim at the gable.
Recommend repairing and or replacing damaged wood.

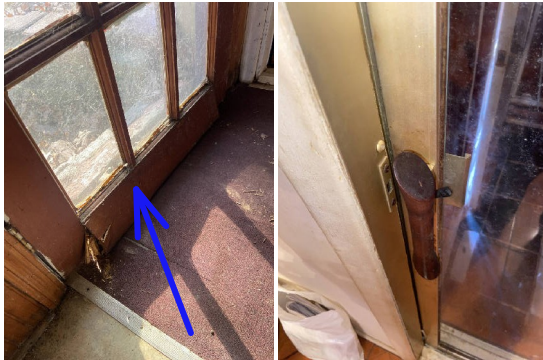
Entry Doors: Wood, sliding glass, Metal~ 1) Back exterior wood door bottom wood panel is loose and rubs against the floor.

2) Sliding glass door will not lock.

Recommend repairing and or replacing door.

Recommend readjusting.

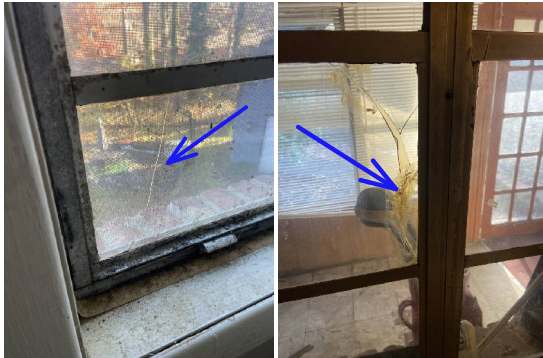
Windows: Vinyl double hung, wood single hung, fixed non opening, aluminum~ Front bedroom aluminum window, basement window, and Dining room window have cracks in the glass window panes.

Recommend repairing and or replacing.

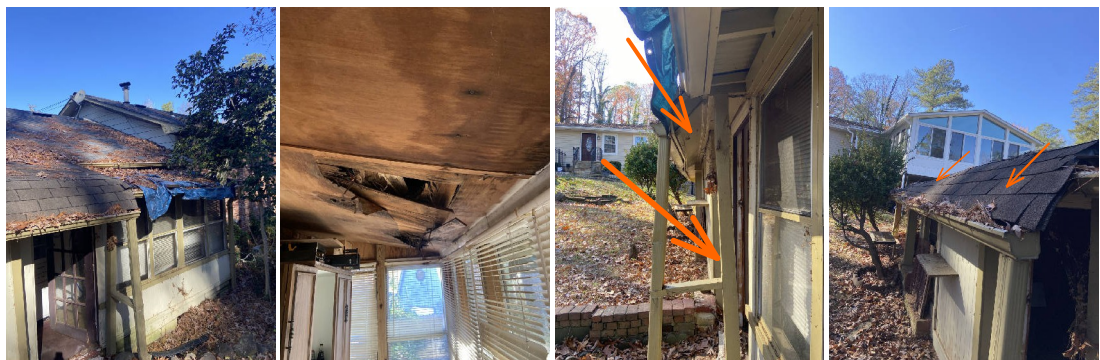
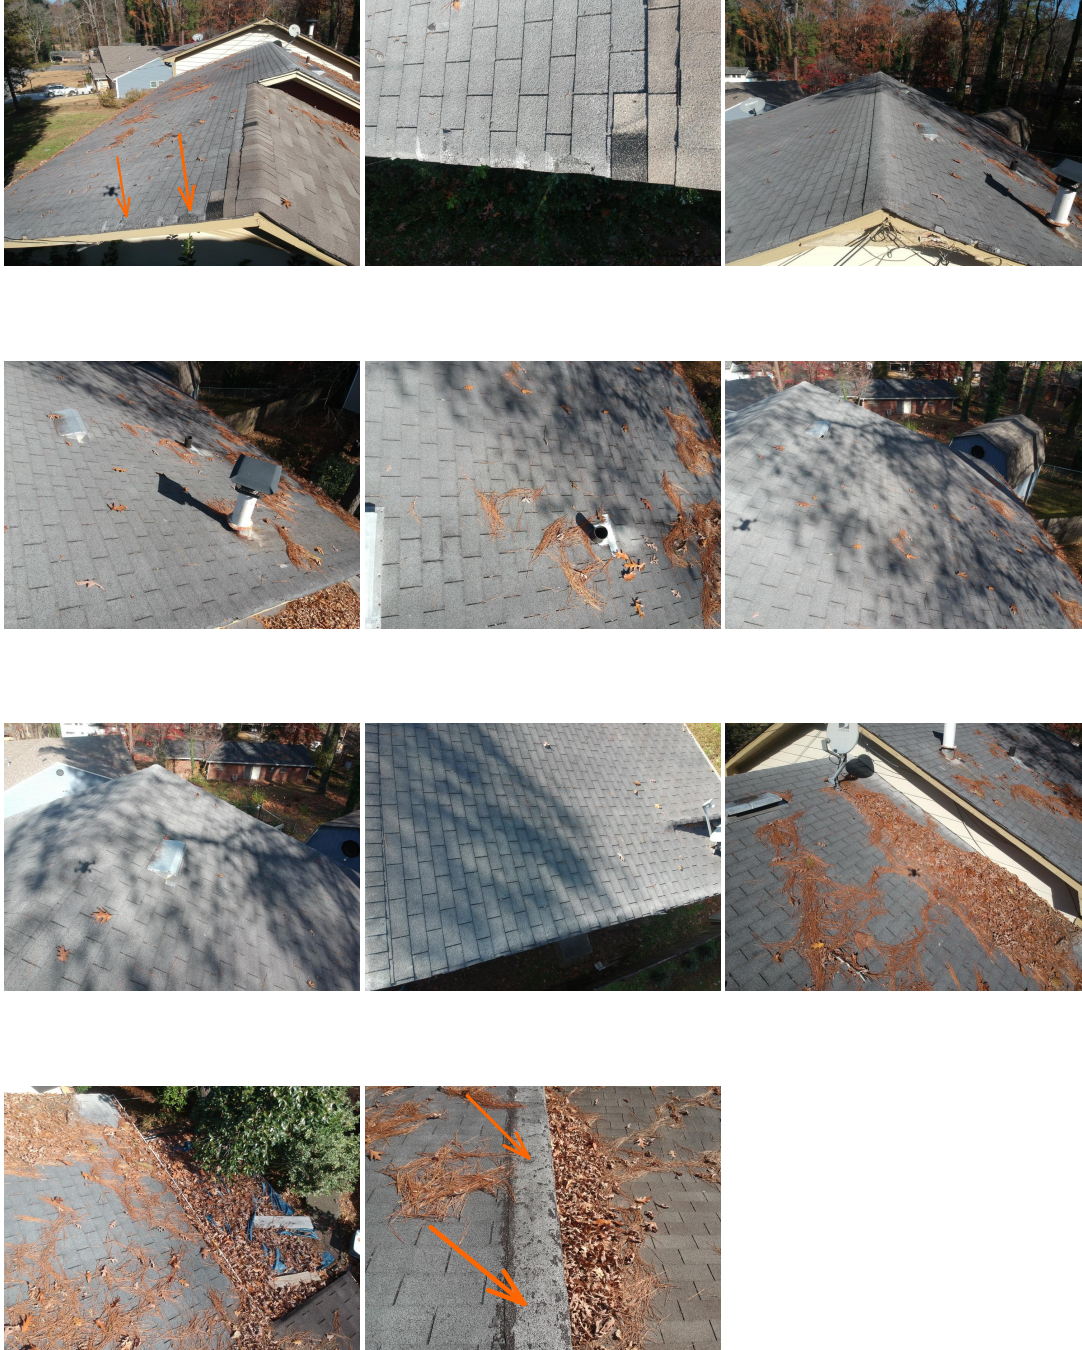
4) Damaged shingles on the drip edge of the roof.

5) Past repairs do not appear to be up to roofing trade standards.

Recommend having a licensed professional roofer further evaluate for repairs and or replacement.

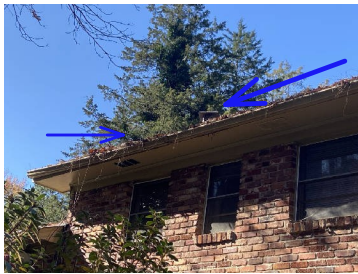
Gutters: Aluminum~ 1) Gutters are full of debris and will inhibit the proper flow of water recommend cleaning.
2) Gutters are not pitched properly and are holding water. Gutters in certain areas sloped incorrectly. This condition can result in water pooling in the gutters, which will encourage corrosion and shorten gutter lifespan. It can also result in spillage and runoff draining to the foundation. Gutter spillage can result in excessively high moisture levels in soil at the foundation. The Inspector recommends repair of the roof drainage system to help protect the home structure and occupants. All work should be performed by a qualified contractor.

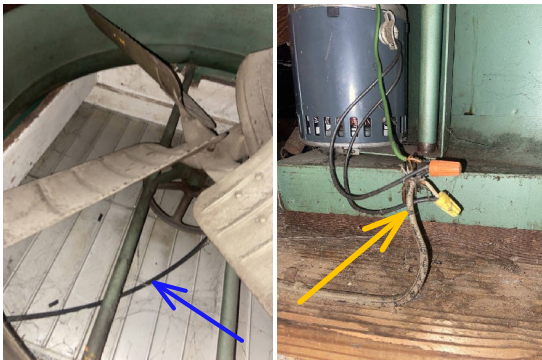
Attic Fan: Direct drive~ 1) Broken rubber fan motor belt.

2) Safety hazard, wire connections to attic fan are not housed inside a protective junction box.

Recommend replacing belt for a new one.

Recommend having an electrician remediate.

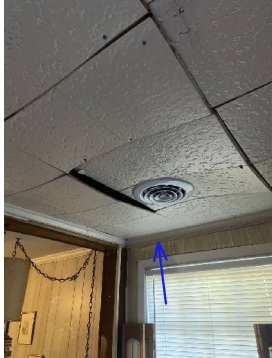
Ceilings: Paint, drop down ceiling ~ **Some of the ceiling tiles need to be readjusted.**

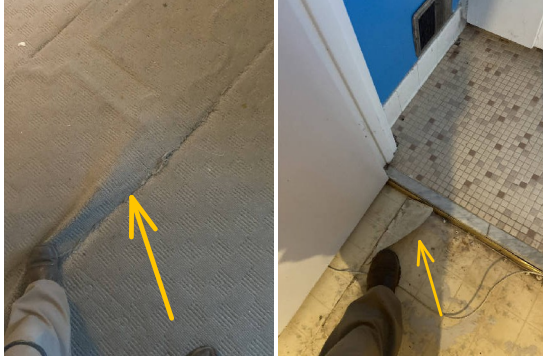
Floors: Carpet, Tile, Vinyl floor covering, Laminate~ **1) Loose carpet is creating a trip hazard. Recommend stretching carpet.**
2) Pulled up vinyl floor covering in back bedroom in front of bathroom door is creating a trip hazard.

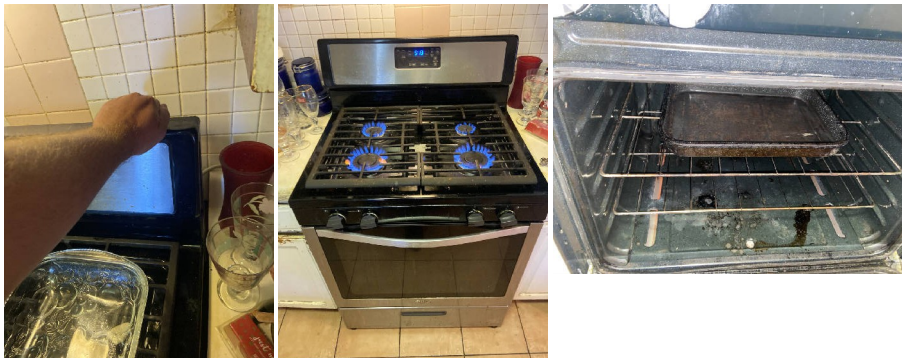
Cooking Appliances: Whirlpool~ **No anti tip bracket installed. Recommend installing an anti tip bracket for safety.**

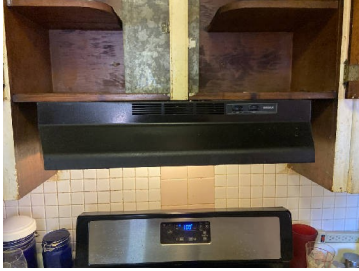
Ventilator: Broan~ **Fan motor will not turn on. Recommend having a appliance technician further evaluate.**

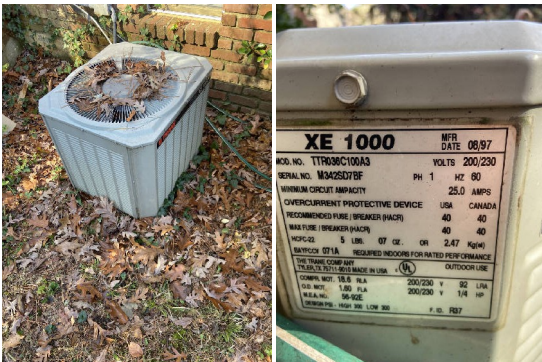
Refrigerant Lines: R22~ The HVAC unit is may be still functional and serviceable but uses the refrigerant R22 . Under the Clean Air Act, the EPA is required to eliminate different types of R-22 refrigerant in specific phases, making R-22 refrigerant much harder to source. The production of R-22 refrigerant was dramatically reduced in 2014 and production of R-22 refrigerant was totally phased out as of Jan 1st 2020. Unfortunately the new refrigerant R410A is NOT compatible with older systems. Homes with older systems that are using R22 should be advised to reserve some funds for a replacement in the future.

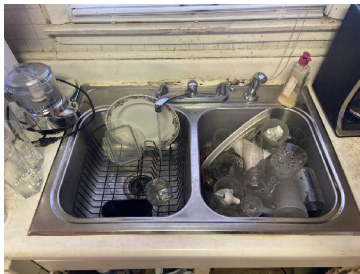
Service Line: unknown not observable
Main Water Shutoff: Street
Water Lines: Galvanized, PEX~ **Galvanized supply piping corrodes from inside causing decreased flow-rates until total failure. Recommend upgrading.**
Vent Pipes: Cast iron
Drain Pipes: Cast iron
Service Caps: Accessible
Kitchen Sink: Stainless Steel

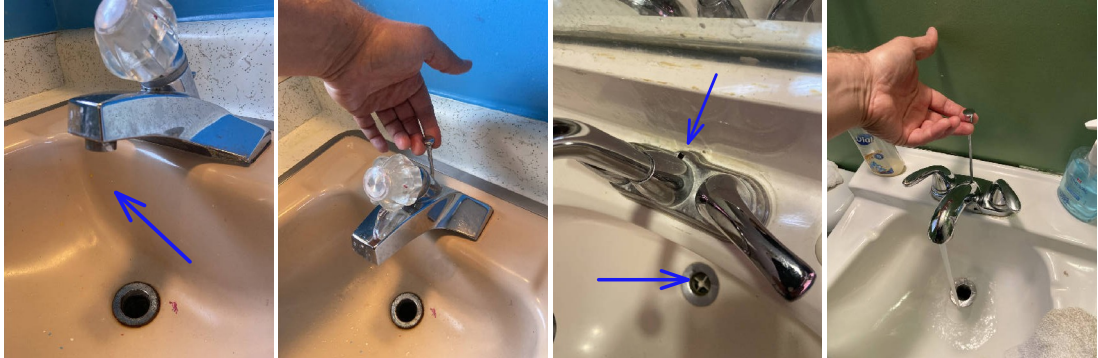
Faucets/Traps: Stainless steel ~ 1) Back bathroom vanity sink faucet has a slow drip. Recommend repairing and or replacing faucet.
2) Bathroom vanity sink stoppers are not functioning. Recommend repairing.

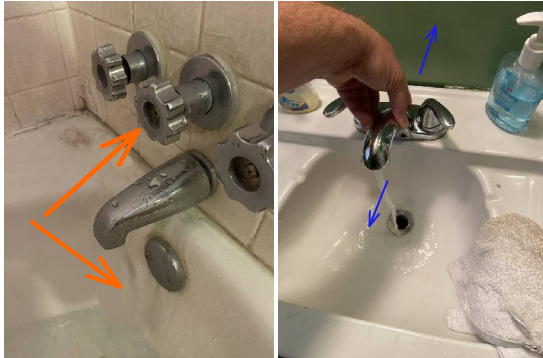
Plumbing/Fixtures: Stainless Steel~ 1) Water diverter in back bathroom tub is not functioning. Recommend having a plumber repair and or replace water diverter.
2) Minor concern, half bath vanity sink faucet is loose. Recommend tightening.

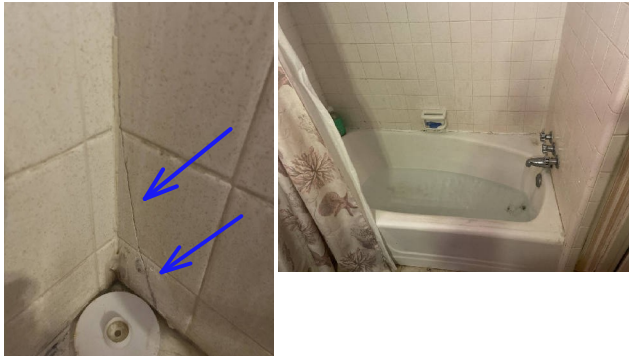
Tub/Surround: Porcelain tub and ceramic tile surround~ 1) Grout is Loose/cracked in corners. Corners should be caulked with a silicon-based and color matched caulk made by the grout manufacturer. As a house "breathes"(expands and contracts) grouted corners will typically crack.
2) Three cracked tub shower tiles. Recommend sealing cracks.

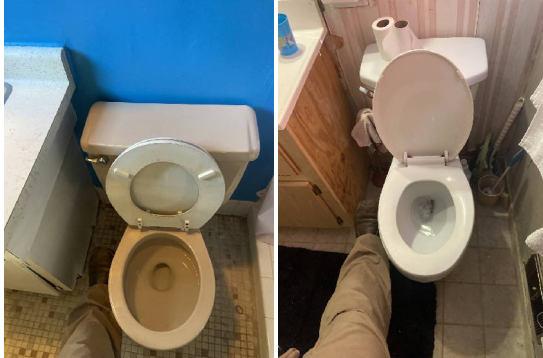
Toilets: Loose at the floor ...Functional no leaks at the time of inspection~ **The toilets in the full bathrooms are loose at the floor and will require tightening of the closet bolts at a minimum. As the toilet is jarred around, it is possible for the wax ring at the base to become damage and leak. Recommend repair or replace as necessary.**

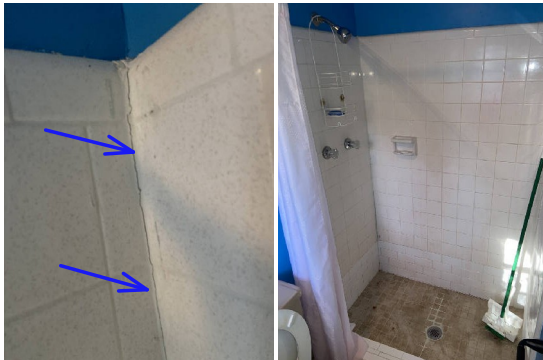
Shower/Surround: Custom tile shower~ **Loose/cracked grout in corners. Corners should be caulked with a silicon-based and color matched caulk made by the grout manufacturer. As a house "breathes"(expands and contracts) grouted corners will typically crack.**

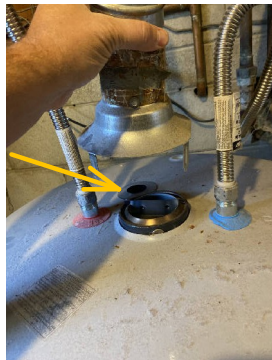
Flue Pipe: Double wall~ **Flue pipe connector collar is not secured to the top of the hot water heater.**
Recommend fastening.

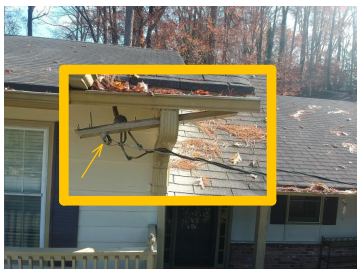
Service Entrance: Above Ground From Mast~ **Electrical service line eye hook mount has pulled away the board that was attached to the eve.**
Recommend having the power company refasten the service line to a secured eye hook to the house.

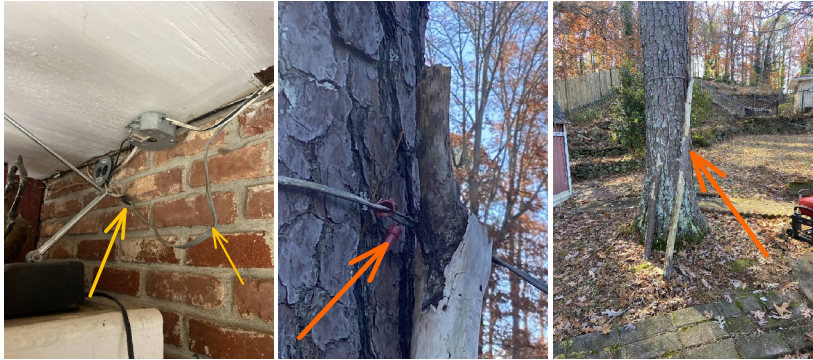
2) The use of Improper electrical wire from house to outside outbuilding, hanging low and wire connections are braced up with a stick.

Recommend having an electrician remediate.

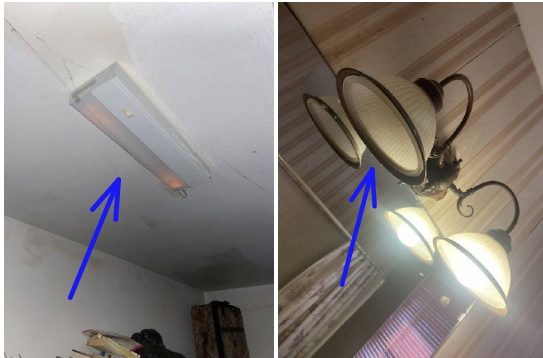
2) Various light fixtures are missing light bulbs and or have burned out bulbs.

Recommend replacing ballast and or replacing light fixture.

Recommend replacing bulbs and retesting light fixtures.

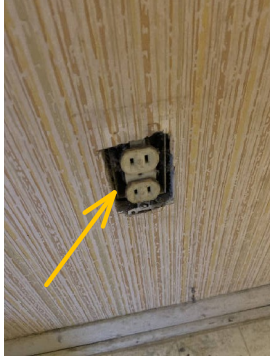
120 VAC Outlets: Ungrounded~ 1) Missing electrical wall outlet covers.

Recommend installing protective covers.

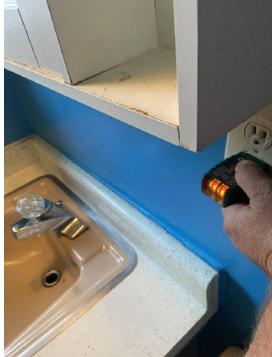
GFCI: Not present~ Although not required when this house was built, consider upgrading the receptacles in wet areas to GFCI protected for improved safety.

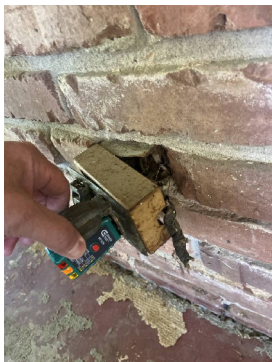
Exterior Electric Outlets: 110 VAC~ 1) Exterior wall outlet in car port is a Non-GFCI circuit - consider a safety upgrade by installing a GFCI circuit /outlet.
2) Carport exterior wall outlet receptacle junction box is loose.

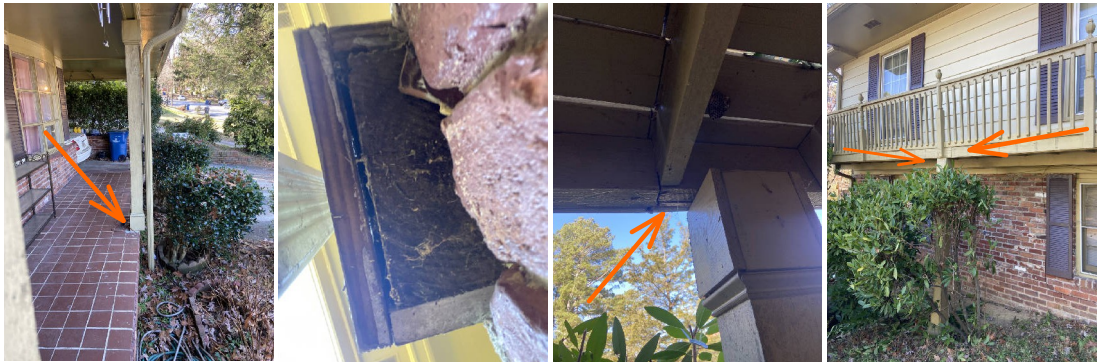
Structure Type: Wood frame
Foundation: Poured slab, Block
Differential Movement:
Beams: Solid wood
Bearing Walls: Frame
Joists/Trusses: 2x10
Piers/Posts: Wood~ **1) Center front porch post is hanging half way off the porch floor.**
2) Post holding up the front framing band on the decorative front balcony is not positioned underneath where the framing bands join causing a slope.
Recommend having a contractor readjust posts.

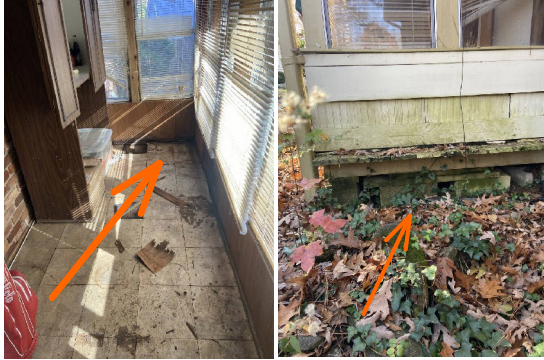
Subfloor: Plywood~ Sun room plywood and framing is slopping and the framing may have be compromised with noted cinder blocking and bracing present. Recommend having a contractor further evaluate.
