Inspection Report

Prepared for~Jennifer & James Thomas

4883 Arcado Rd SW
Lilburn, GA 30047

DS Murphy Inspections

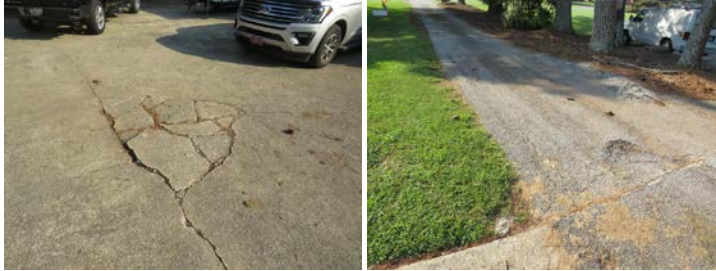
Driveway: Concrete~ Concrete pitted and chipped. Driveway is still functional, but recommend monitoring for further deterioration.

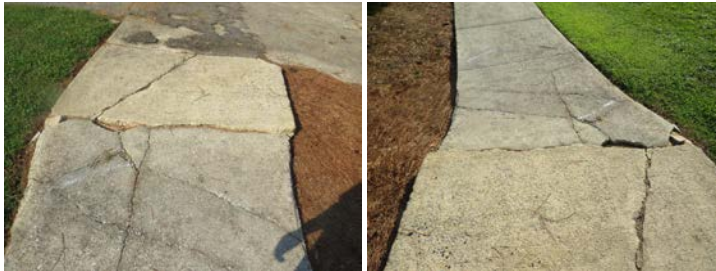
Walks: Concrete~ Heaves in concrete causing trip hazard. Recommend repair or replace as necessary.

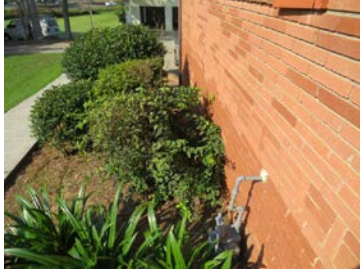
Vegetation: Trees, Ivy, Shrubs/Weeds, Decorative ~ **Vegetation should be trimmed back away from house two feet to allow the wall proper room for drying.**

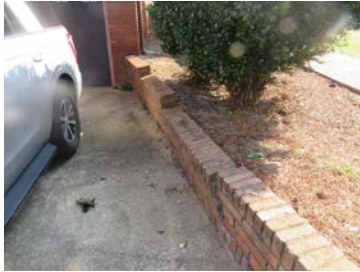
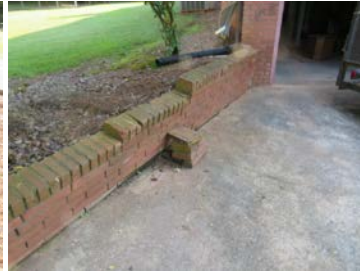
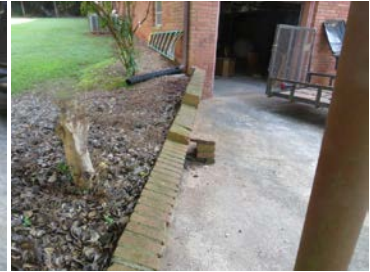
1. Retaining Walls: Brick~ Brick retaining walls have clearly moved from original position. They have a significant lean going away from the earth they are retaining. Recommend further evaluation by a licensed professional as these walls will eventually fail.

Retaining Walls: Brick~ **Brick retaining walls have clearly moved from original position. They have a significant lean going away from the earth they are retaining. Recommend further evaluation by a licensed professional as these walls will eventually fail.**

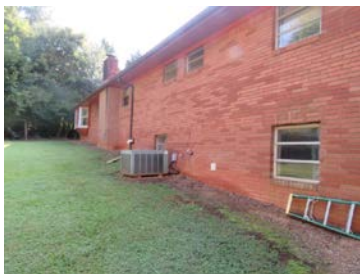
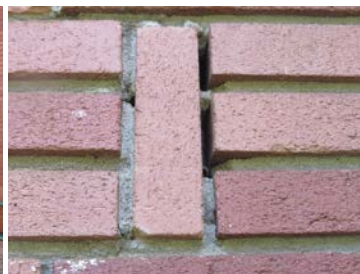
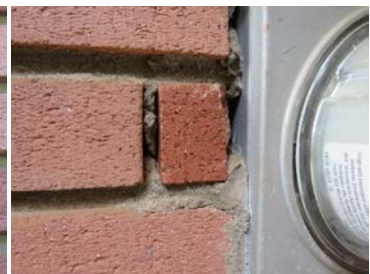
Type: Brick~ **Repointing of mortar recommended where deteriorated in brick.**

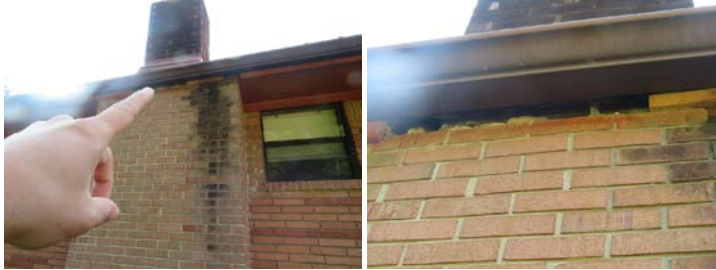
Fascia: Wood~ Gaps in fascia board on backside of chimney. It appears there is water getting behind gutters as there is water stains on chimney bricks. Recommend sealing all gaps and replacing missing fascia.

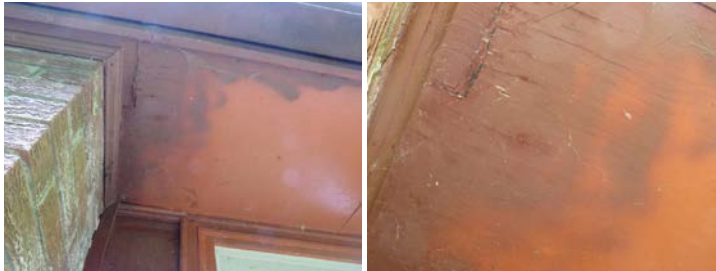
Soffits: Wood~ Rot noted at various areas. Recommend repair or replace as necessary.

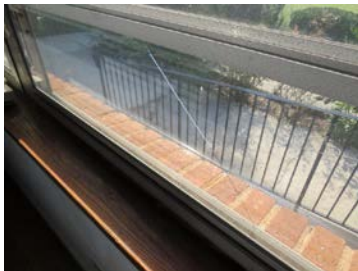
Windows: Aluminum double hung, Wood double hung~ A couple windows were noted as cracked. Recommend repair or replace as necessary.

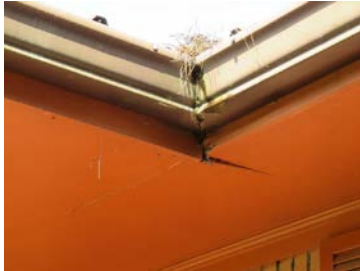
Gutters: Aluminum~ **Gutter is leaking at the seam. Recommend repair or replace as necessary.**

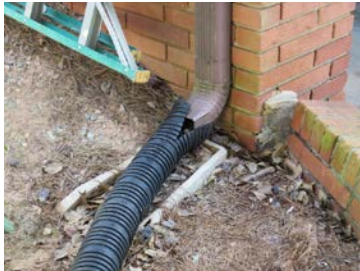
Downspouts: Aluminum~ **Downspout extension not secure. This needs to be secured properly to function properly.**

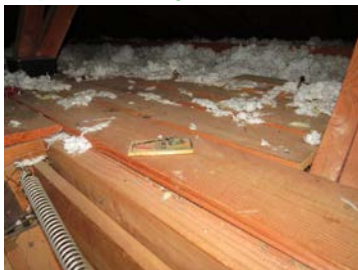
Wiring/Lighting: 110 VAC lighting circuit
Pest Activity: None noted at the time of inspection. **Empty trap noted in attic. No visible signs of pest activity.**

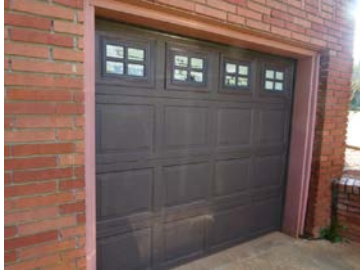
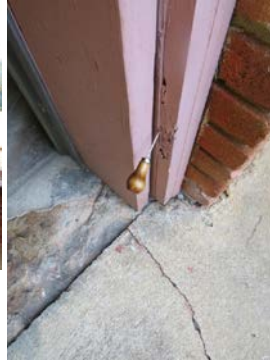
Garage Doors: Insulated aluminum~ **Minor wood rot noted at the bottom of the jamb(s) for the garage door. Recommend repair or replace as necessary.**

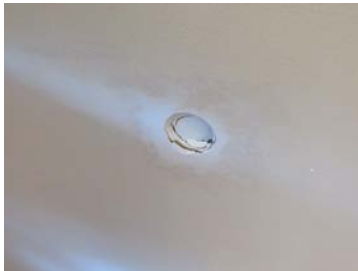
Walls: Paint, Paneling~ Drywall has been damaged. Recommend repair or replace as necessary.

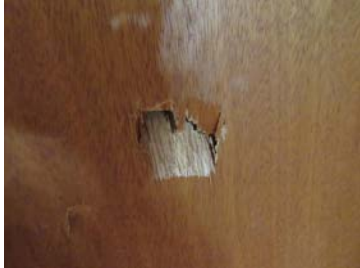
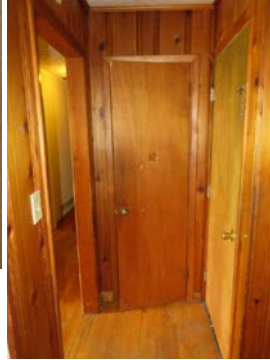
Doors: Hollow wood~ **Damage to hallway closet door. This door would also not shut. Repair or replace as necessary.**

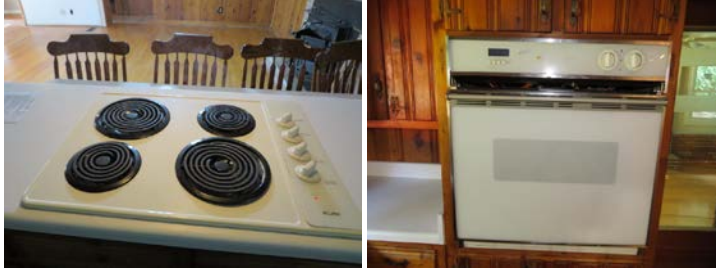
Cooking Appliances: Tested and functional at time of inspection~ Oven heated to desired temp but screen to the left was not functional at the time of inspection. Recommend further evaluation by licensed professional.

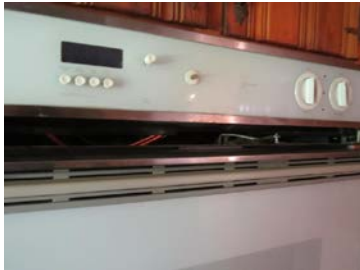
Cooking Appliances: Tested and functional at time of inspection~ Cover plate missing above oven door exposing wiring. This is a safety hazard.

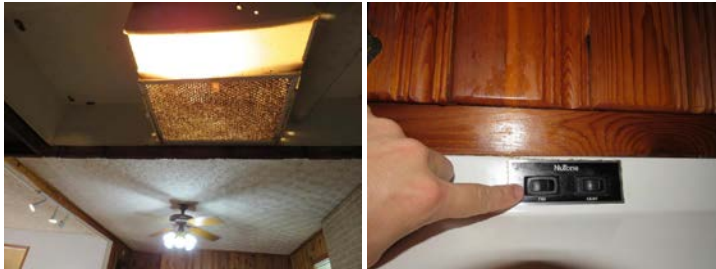
Ventilator: Nutone~ Vent fan inoperative at the time of inspection. The overhead light on the unit was functioning properly. Recommend further evaluation by a licensed professional to determine if fan motor is broken or just wired incorrectly.,

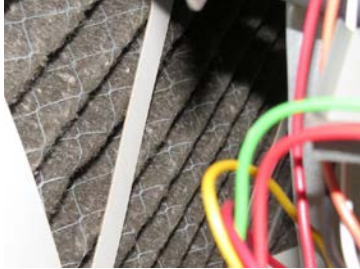
Blower Fan/Filter: Disposable filter~ Filters are dirty and should be replaced.

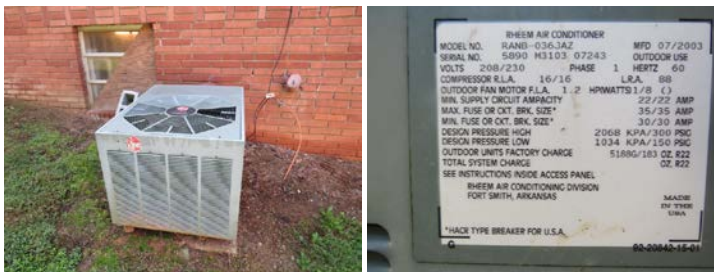
A/C System Operation: Functional~ AC units typically last about fifteen (15) years. Depending on how well they are maintained, they can last longer, or not as long. This unit is nearing the end of it's stated life span, though it remains functional.

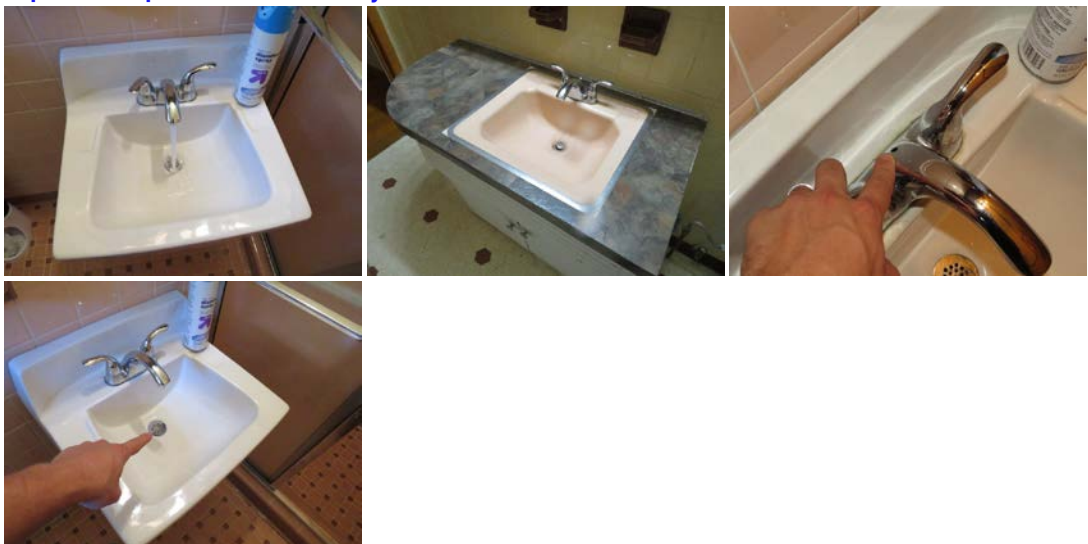
Bathroom Sink/Basin: Pedestal, Porcelain~ **Drain stopper pull handle is missing. Recommend repair or replace as necessary.**

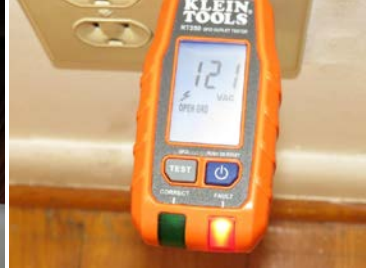
120 Vac Outlets: 110 VAC~ Majority of the outlets in the home have an open ground. This is typical for a house this age as a ground was not required when it was built. Without the ground present, errors that occur with your outlet may cause arcing sparks and electrical charge that can spawn fire along walls or on nearby furniture and fixtures.

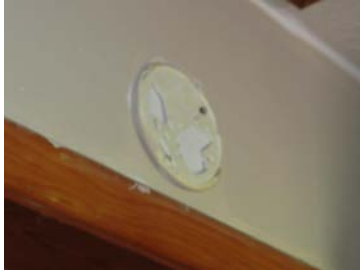
Smoke Detectors: Not Present~ **Current standards recommend smoke detectors be installed any room with a fireplace on all floors, outside sleeping areas, and in all bedrooms.**

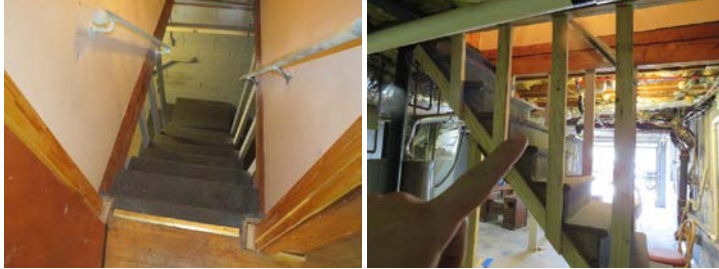
Floor/Slab: Poured slab
Stairs (Interior): Wood stairs with wood handrails~ **Missing return caps at end of handrails. This is a safety hazard as clothing or other items could get caught and cause a fall. Consider a safety upgrade by installing return caps at top and bottom of railings.**

Hand rails have improper baluster spacing. Balusters should be spaced no farther than four (4) inches apart for safety reasons. At the time of construction this may have been an acceptable building practice, but recommend upgrading for safety.
