DS Murphy Inspections  
Suwannee, GA 30024  
678 573 6005

# Inspection Report

**405 County Line Rd  
Fayetteville, Ga 30215**

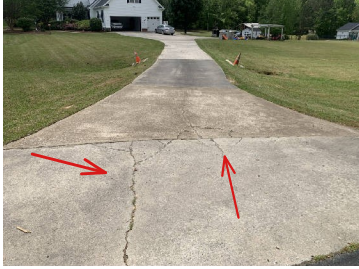
Driveway: Concrete~ Cracks in concrete typical for the age of property. Recommend sealing.

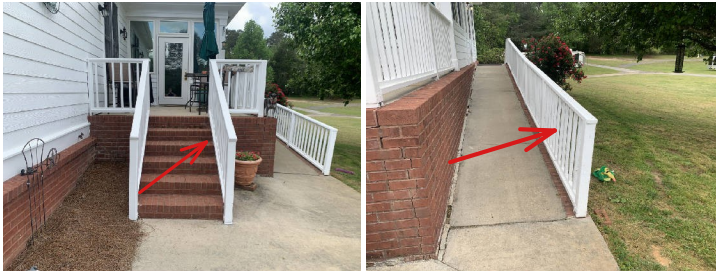
Steps: Brick~ The railing was loose at the right side steps and ramp. Recommend securing the handrail.

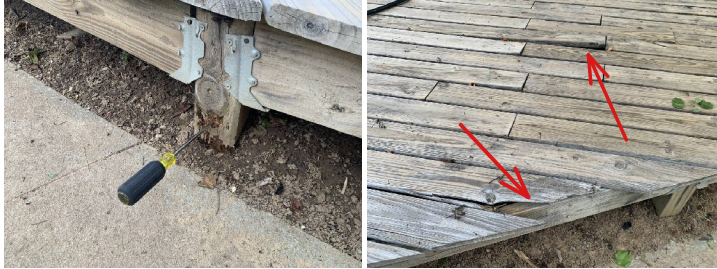
Deck: Wood~ Slight rot observed at the rear deck footers. Recommend repair or replace as necessary.

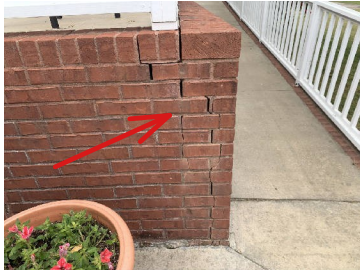
Rear Porch: Concrete, Brick~ Settlement cracks noted at the porch. These cracks are typical and should be sealed.

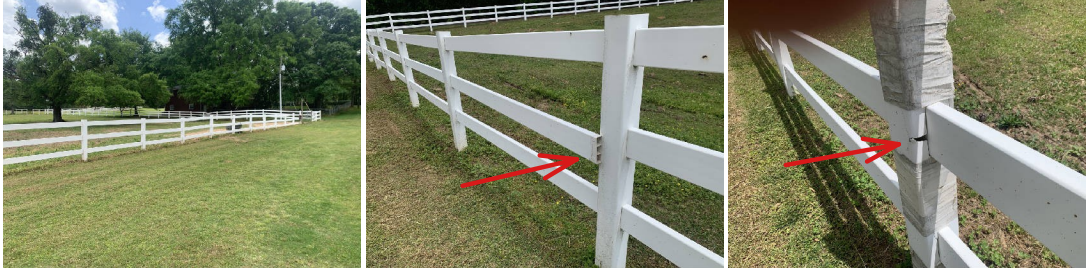
Fences: Vinyl~ Slight damage to one of the fence posts. Recommend remediation as necessary.

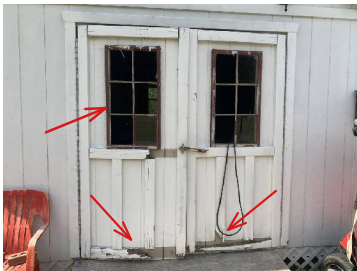
Doors: Solid wood~ **Deterioration noted at the outbuilding doors as well as knocked out glass panes. Recommend repair or replace.**

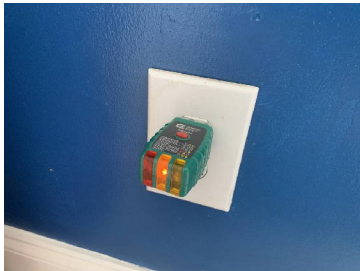
Electrical: 110 VAC outlets and lighting circuits~ **Open ground outlet noted in the pool house. Recommend remediation by a licensed electrician.**

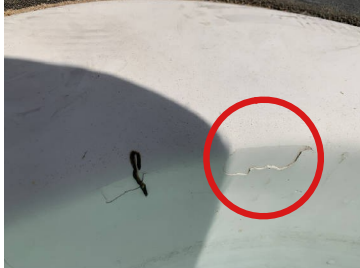
Liner: Fiberglass~ Slight crack in the pool liner that may hasten deterioration and cause further damage. Recommend remediation as necessary.

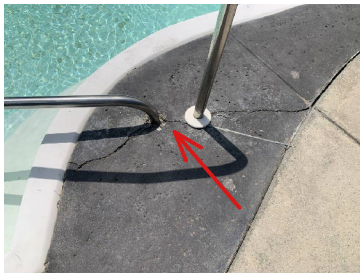
Deck: Concrete~ Concrete apron is cracked. This is typical and should be sealed to prevent further deterioration.

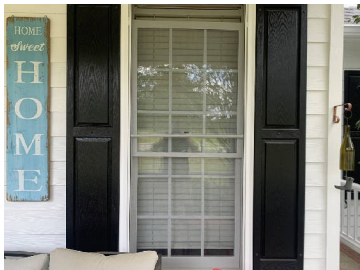
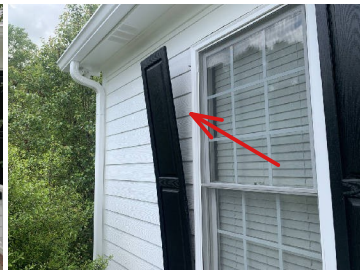
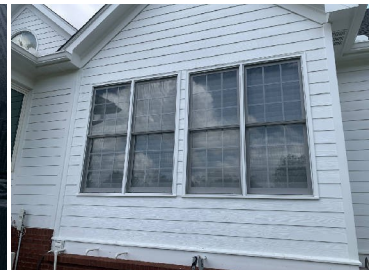
Windows: Vinyl single hung~ Window shutter at the front left of the home was detached at the time of the inspection. Recommend remediation as necessary.

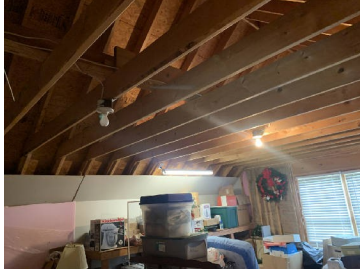
Wiring/Lighting: 110 VAC lighting circuit~ **Unknown if the bulb in the attic lighting circuit is burnt. Recommend replacing bulb first and then further evaluation and remediation if necessary.**

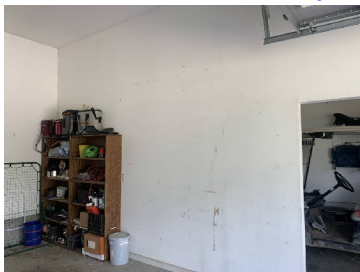
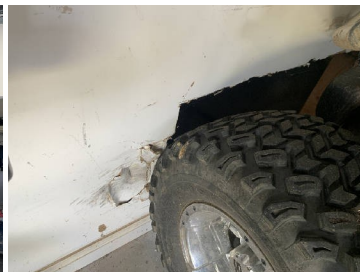
Walls: Paint~ **Slight damage to the garage wall where the golf cart was parked. Recommend remediation as necessary.**

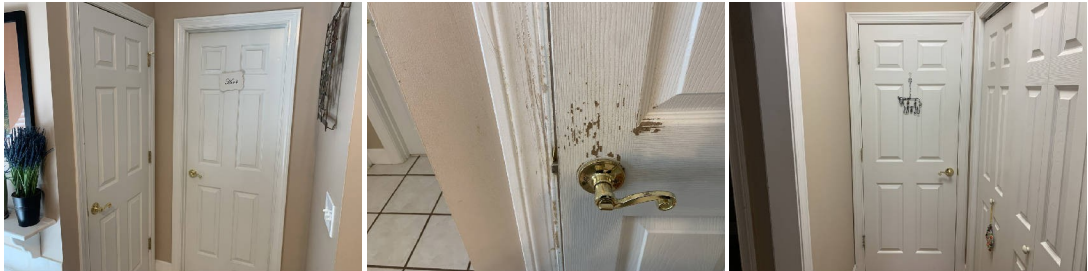
Doors: Hollow wood, Bi-fold~ Slight deterioration at the primary bath door. Recommend repair or replace as necessary.

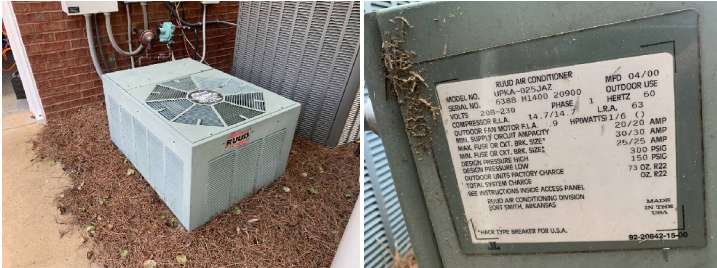
A/C System Operation: Functional~ AC units typically last about fifteen (15) years. Depending on how well they are maintained, they can last longer, or not as long. This unit is nearing the end of it's stated life span, though it remains functional.

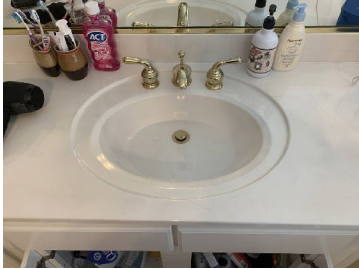
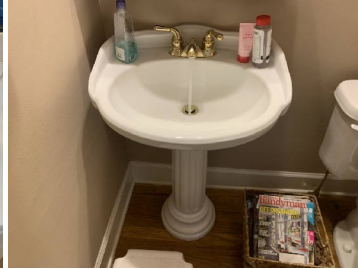
Bathroom Sink/Basin: Molded single bowl, Pedestal~ **No drain stopper present at one of the primary bath sinks. Recommend adding as necessary.**

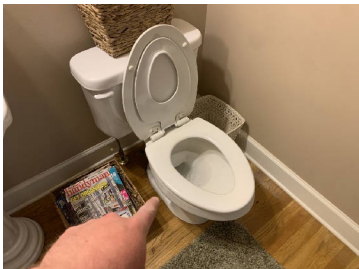
Toilets: Functional at time of inspection no leaks closet bolts secure~ **The main floor hallway toilet is loose at the floor and will require tightening of the closet bolts at a minimum. As the toilet is jarred around, it is possible for the wax ring at the base to become damage and leak. Recommend repair or replace as necessary.**

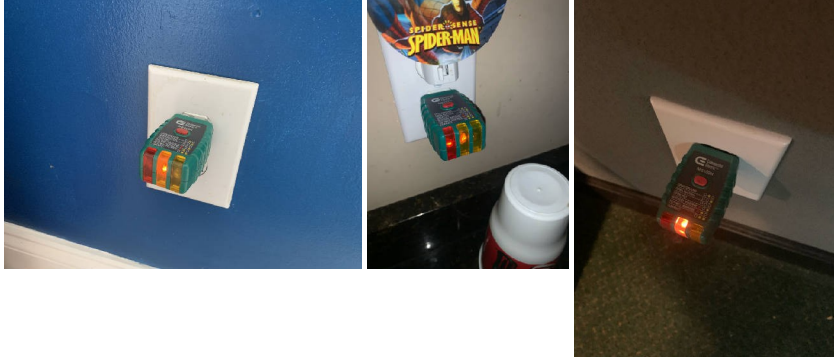
120 Vac Outlets: 110 VAC GFCI~ Multiple open ground or hot/neutral reverse outlets noted at various areas in the basement. Recommend remediation by a licensed electrician.

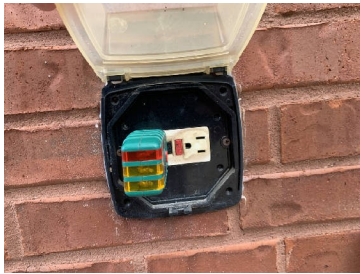
Exterior Electric Outlets: 110 VAC GFCI~ Outlets at the rear wooden deck was tripped at the time of the inspection and would not reset. Recommend further evaluation and remediation by a licensed electrician.

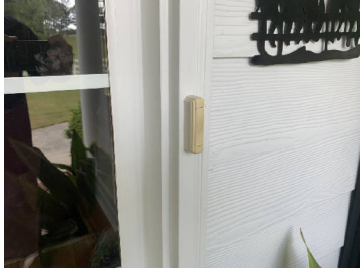
Door Bell: Hard wired~ **The doorbell was inoperative at the time of inspection.**
