# Inspection Report

**5577 Skyland Dr  
Forrest Park , Ga 30297**

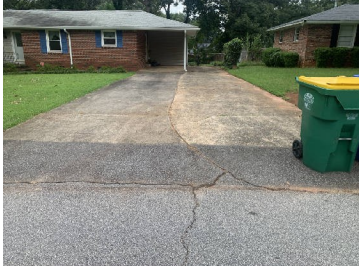
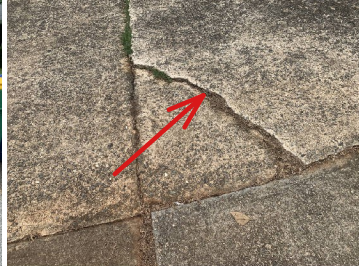
Driveway: Concrete~ Cracks in concrete typical for the age of property. Recommend sealing.

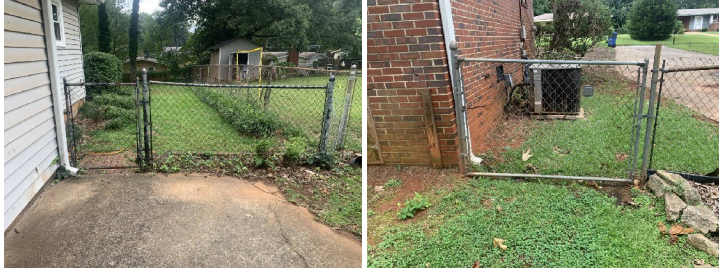
Fences: Chain link~ The fence and both gates appear to be in good condition.

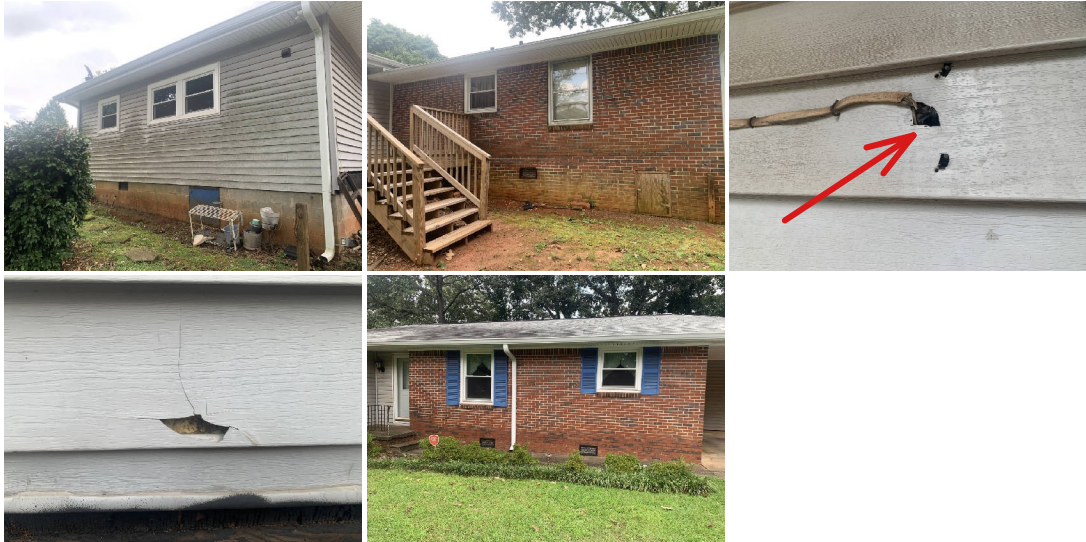
Type: Brick veneer, Vinyl siding~ Recommend filling all holes/gaps in the vinyl siding.

1. All Exterior Surface Type: Brick veneer, Vinyl siding~ [Recommend filling all holes/gaps in the vinyl siding.](#)

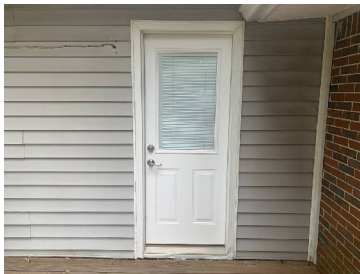
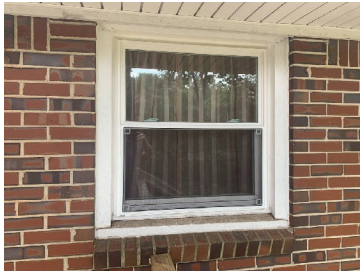
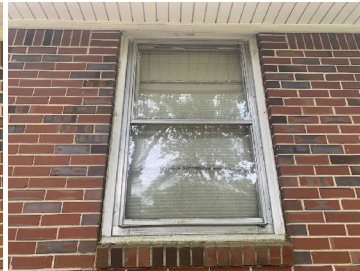
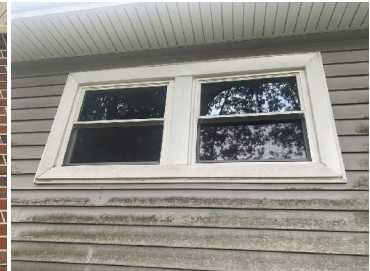
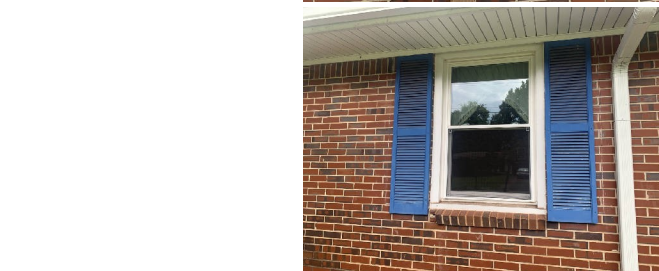
Windows: Vinyl single hung~ All windows that were tested functioned appropriately.

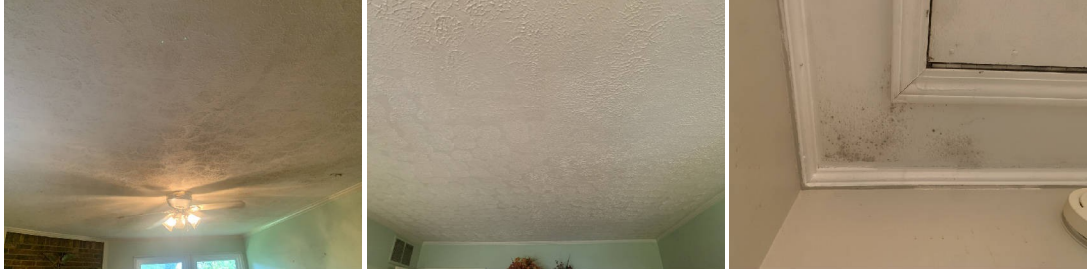
Ceilings: Texture paint~ **Unknown** as to the actual defect but there may have been possible mold growth at the ceiling next to attic entrance. I did not see any signs of water intrusion from the attic. Recommend further evaluation and remediation if necessary.

1. Ceilings: Texture paint~ Unknown as to the actual defect but there may have been possible mold growth at the ceiling next to attic entrance. I did not see any signs of water intrusion from the attic. Recommend further evaluation and remediation if necessary.

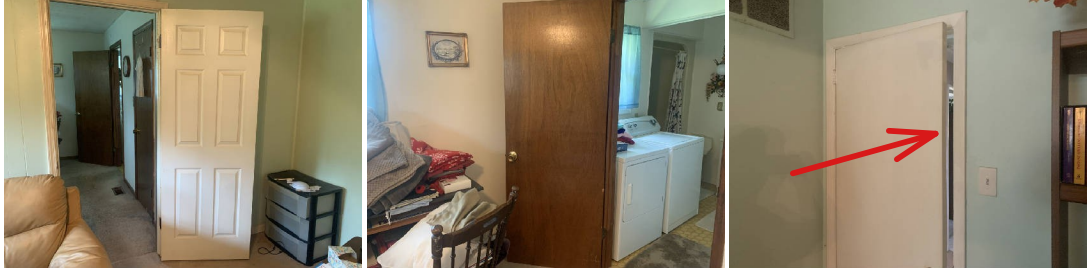
Doors: Hollow wood~ **One of the hallway doors was out of square and would not fully shut. Adjustments are needed.**

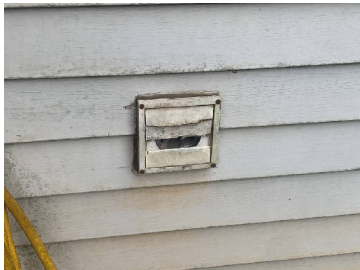
Dryer Vent: Plastic flex~ **The dryer vent cover was chipped at the time of the inspection. Recommend repair or replace as necessaryZ**

4. Dryer Vent: Plastic flex~ [The dryer vent cover was chipped at the time of the inspection. Recommend repair or replace as necessaryZ](#)

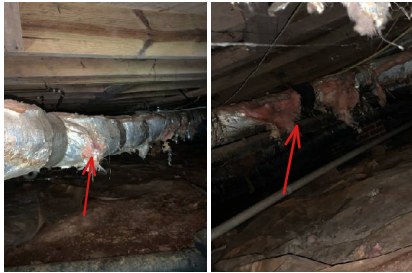
Ductwork & Distribution: Insulflex duct~ Rips/tears in various areas of the ductwork. Airflow was adequate at the time of the inspection. Recommend further monitoring and remediation if needed.

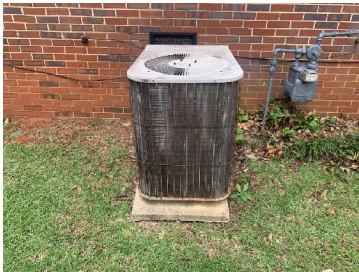
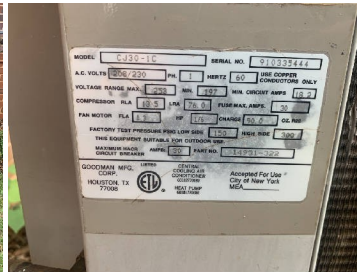
A/C System Operation: Functional~ AC units typically last about fifteen (15) years. Depending on how well they are maintained, they can last longer, or not as long. This unit is nearing the end of it's stated life span, though it remains functional. Recommend budgeting for a replacement should one be needed in the future.

2. Left side (facing front) Air Conditioning System A/C System Operation: Functional~ AC units typically last about fifteen (15) years. Depending on how well they are maintained, they can last longer, or not as long. This unit is nearing the end of it's stated life span, though it remains functional. Recommend budgeting for a replacement should one be needed in the future.

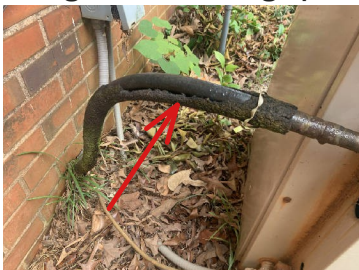
Refrigerant Lines: High pressure~ Torn/deteriorated insulation. Repair or replace as necessary

5. Left side (facing front) Air Conditioning System Refrigerant Lines: High pressure~ [Torn/deteriorated insulation. Repair or replace as necessary](#)

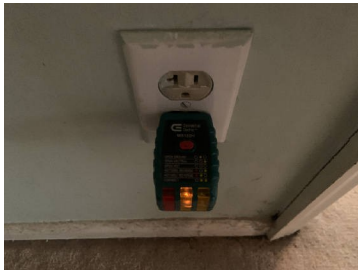
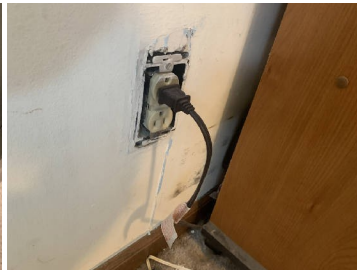
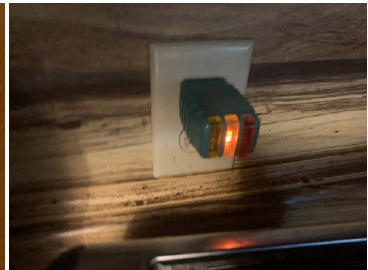
120 Vac Outlets: 110 VAC GFCI~ **Open ground outlet noted in the front room and in the kitchen by the stove.**

**There was also a missing outlet cover in the bedroom off of the laundry area. ~ minor defect**

3. 120 Vac Outlets: 110 VAC GFCI~ Open ground outlet noted in the front room and in the kitchen by the stove.

There was also a missing outlet cover in the bedroom off of the laundry area. ~ minor defect

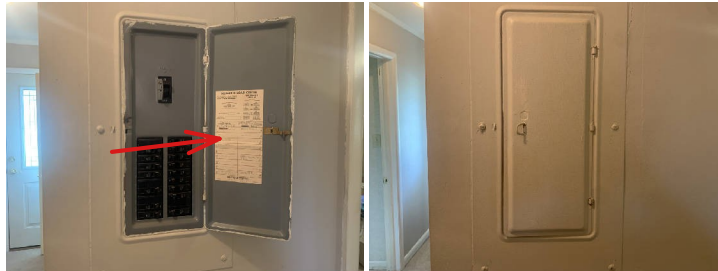
Manufacturer: Square D~ **Legend for breakers is not labeled completely. Recommend electrician trace circuits and label panel correctly.**

1. Hallway Electric Panel Manufacturer: Square D~ Legend for breakers is not labeled completely. Recommend electrician trace circuits and label panel correctly.
2. Smoke Detectors: Battery operated with light~ Current standards recommend smoke detectors be installed any room with a fireplace on all floors, and outside sleeping areas.
3. Carbon Monoxide Detectors: Not Present~ Current standards recommend carbon monoxide detectors be installed on every level of the home, in a central location outside sleeping areas, in any room with a gas fired appliance and in every room with a fireplace.

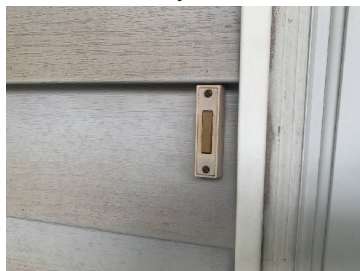
Door Bell: Inoperative ~ **The doorbell was inoperative at the time of inspection.**

6. Door Bell: Inoperative ~ [The doorbell was inoperative at the time of inspection.](#)

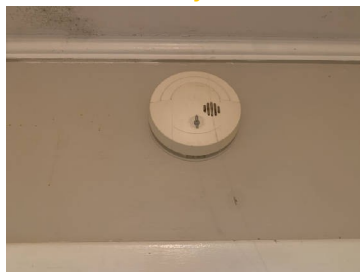
Smoke Detectors: Battery operated with light~ **Current standards recommend smoke detectors be installed any room with a fireplace on all floors, and outside sleeping areas.**
