Inspection Report

Prepared for~Niki Stolarczyk as trustee

**234 Hunting Creek Dr
Marietta, GA 30068**

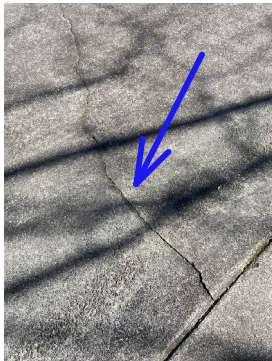
Driveway: Concrete~ Cracks in concrete typical for the age of property. Recommend sealing.

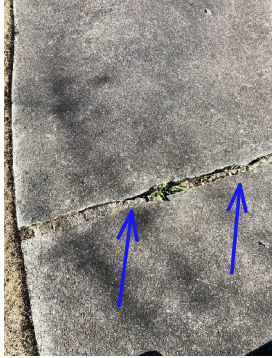
Walks: Concrete~ Settlement cracks noted at the walks. These cracks are typical and should be sealed.

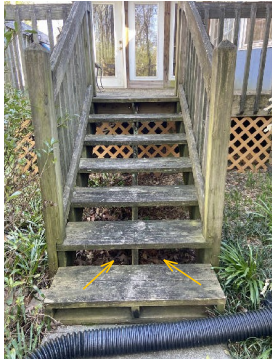
Steps: Wood, Concrete~ Current standards call for stair risers to be enclosed. This is a safety hazard consider a safety upgrade by enclosing.

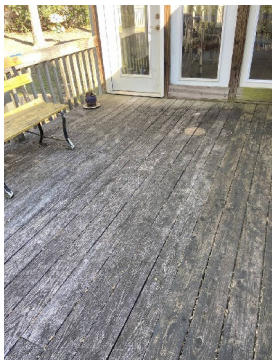
Porch: Concrete
Deck: Treated wood~ Was not able to inspect deck framing from below due to fastened lattice.

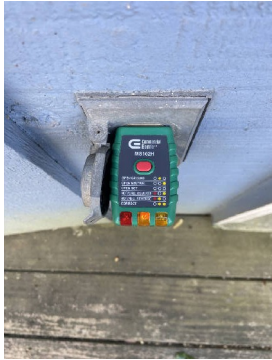
Acceptable	Type: Wood, Brick veneer
Acceptable	Trim: Wood
Acceptable	Fascia: Wood
Acceptable	Soffits: Wood
Acceptable	Door Bell: Hard wired
Acceptable	Exterior Lighting: Surface mount
Safety Hazard	Exterior Electric Outlets: 110 VAC~ 1) Original exterior outlets are not on a GFCI circuit. This is a safety hazard. This may have been acceptable building practice at the time of construction, but recommend upgrading. 2) Deck outlet noted as open grounded. Recommend having an electrician remediate.

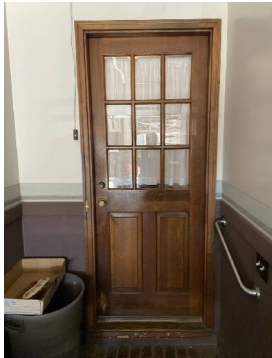
Acceptable	Garage Doors: Wood
Acceptable	Door Operation: Mechanized
Acceptable	Door Opener: Lift Master
Safety Hazard	Service Doors: Wood~ Entry door is not rated for fire. This is a safety hazard consider replacing with a fire rated door.

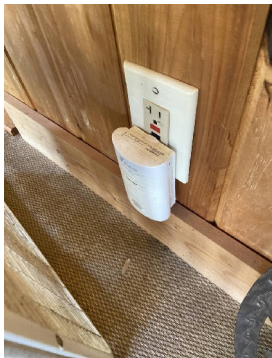
Carbon Monoxide Detectors: Plug in~ **1) Plugged in carbon monoxide detector in sun room is noted plugged into a GFCI outlet and if receptacle is tripped detector may not work. 2) Current standards recommend carbon monoxide detectors be installed on every level of the home, in a central location outside sleeping areas, in any room with a gas fired appliance and in every room with a fireplace.**

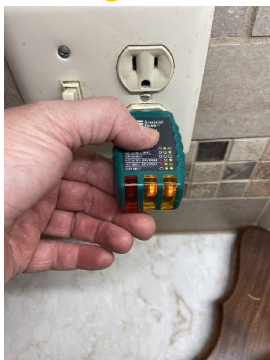
Electrical: 110 VAC outlets and lighting circuits~ **Non-GFCI circuit. This may have been an acceptable building practice at the time of construction, but consider a safety upgrade by installing a GFCI circuit.**

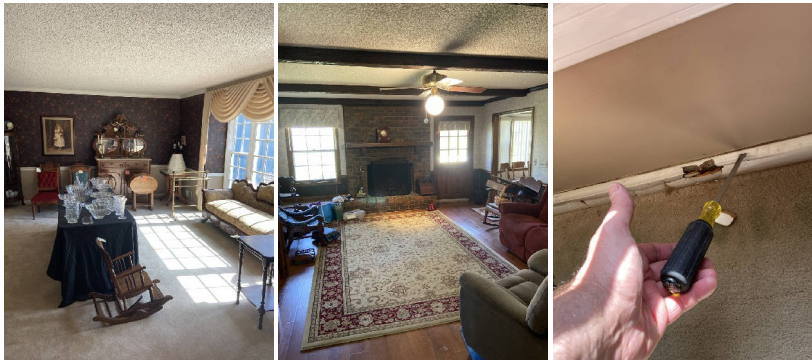
Acceptable	Closet: Cabinetry
Acceptable	Ceiling: Texture paint
Minor Defect	Walls: Paint, Wallpaper~ Minor wood rot noted at interior floor wood trim at bay window. Dry on day of inspection, recommend future monitoring.

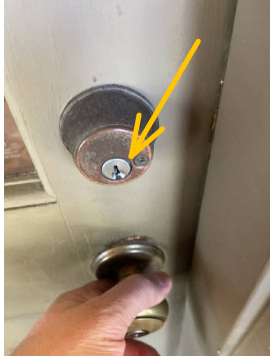
Acceptable	Floor: Vinyl floor covering, Carpet
Safety Hazard	Doors: Exterior exit door~ Deadbolt on door is keyed on both sides. This is a safety hazard should no key be available to exit in an emergency.

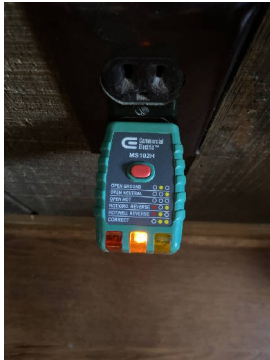
Windows: Wood double hung, Fixed / Non-opening
Electrical: 110 VAC outlets and lighting circuits~ **Outlets in Living room showed an "open ground" when tested.**
Recommend electrician further evaluate and repair or replace as necessary.

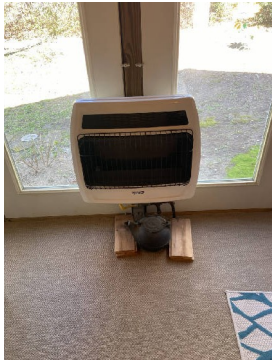
HVAC Source: No air conditioning just a Gas heater~ **Gas heater does not appear to vent to outside the room.**
Carbon monoxide safety concern.

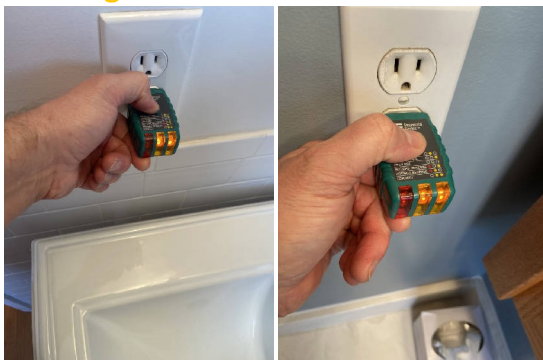
Electrical: 110 VAC outlets and lighting circuits, 110 VAC GFCI~ **Non-GFCI circuit next to pedestal sink in hall bathroom. and bathroom off of laundry room. This may have been an acceptable building practice at the time of construction, but consider a safety upgrade by installing a GFCI circuit.**

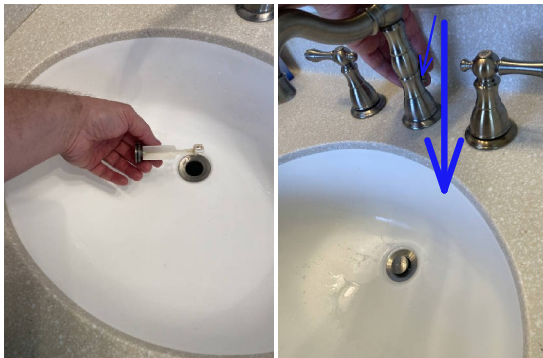
Faucets/Traps: Rubbed bronze, PVC ~ Primary bathroom vanity sink stoppers are not functioning.
Recommend readjusting.

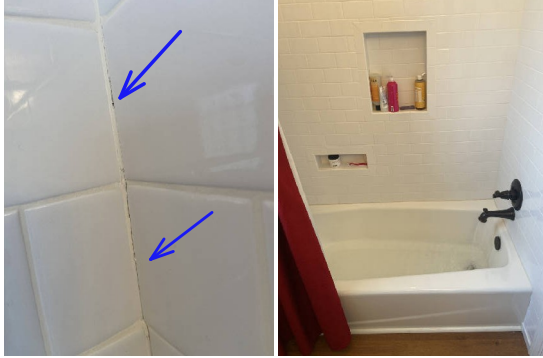
Tub/Surround: Fiberglass tub and ceramic tile surround~ Grout is Loose/cracked in corners. Corners should be caulked with a silicon-based and color matched caulk made by the grout manufacturer. As a house "breathes"(expands and contracts) grouted corners will typically crack.

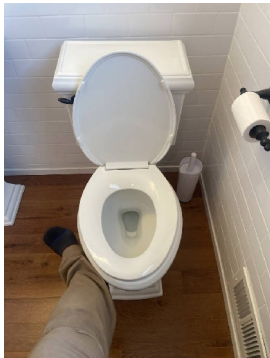
Toilets: Loose at the floor ...Functional no leaks at the time of inspection

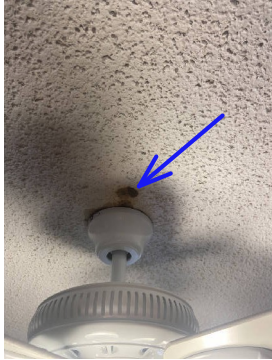
Ceiling: Texture paint~ **Small water staining on ceiling in back left bedroom.**
Dry on day of inspection, recommend future monitoring.

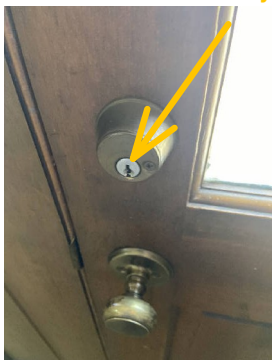
Acceptable	Floor: Concrete
Safety Hazard	Doors: Wood, , Exterior exit door~ Deadbolt on door is keyed on both sides. This is a safety hazard should no key be available to exit in an emergency.

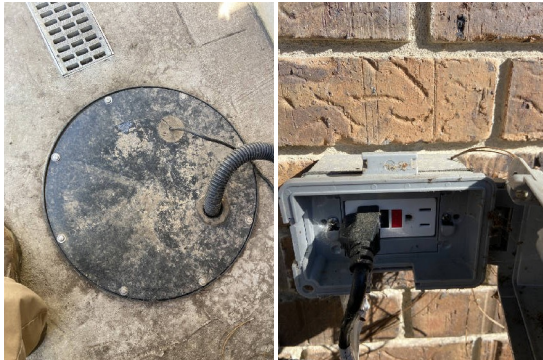
Sump Pump: Submerged~ Exterior sump pump is noted using a GFCI exterior receptacle which if tripped the pump will not be energized.
Recommend having an alarm installed and or have an electrician hardware the energy source to a interior receptacle.

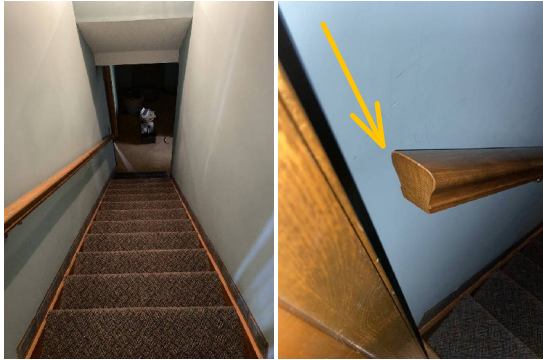
Stairs/Handrails: carpeted stairs with wooden handrails~ **Missing return caps at end of handrails. This is a safety hazard as clothing or other items could get caught and cause a fall. Consider a safety upgrade by installing return caps at top and bottom of railings.**

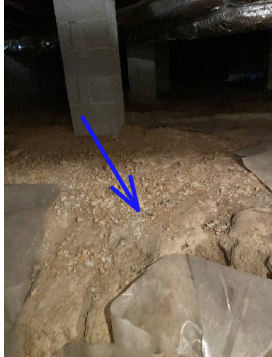
Moisture Barrier: Plastic~ A few areas in the crawlspace should have the plastic readjusted and or reinstalled to cover the dirt.

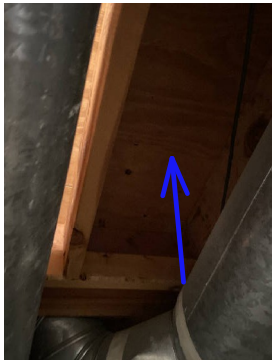
Ventilation: Vents
Electrical: 110 volt lightning
Insulation: None~ Recommend installing fiberglass under sub flooring to gain a more energy efficient home.
