Inspection Report

Prepared for~Amy Martin

**754 Helen Street
Marietta, GA 30064**

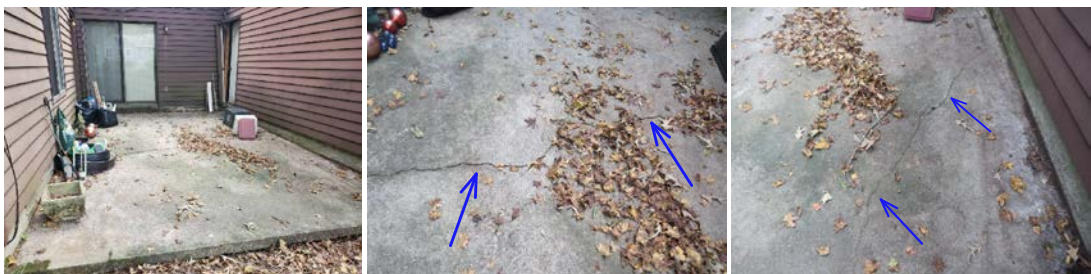
Patio: Concrete~ Settlement cracks noted at the patio. These cracks are typical and should be sealed.

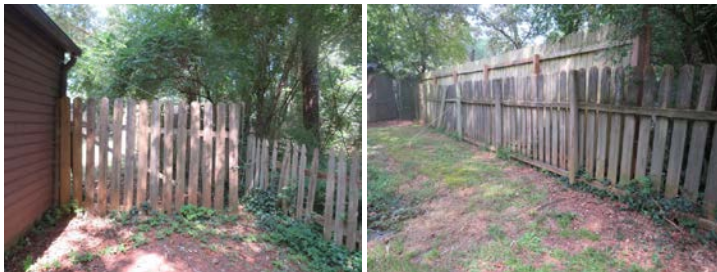
Fences: Wood, Chain link~ The fence is showing its age and needs some deferred maintenance to extend its lifespan damaged or deteriorated at various areas and should be repaired.

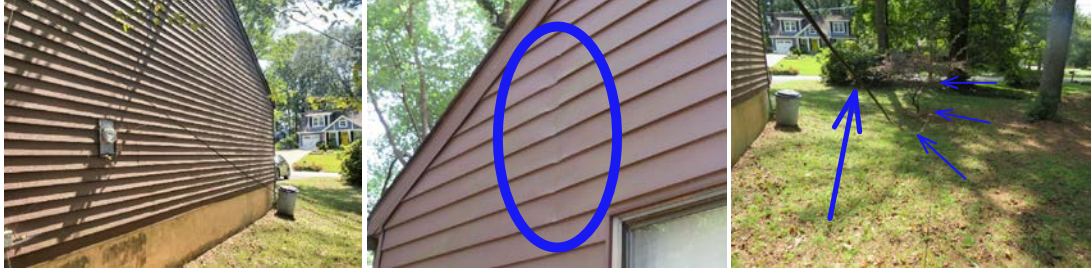
Type: Aluminum siding~ Damage to the siding in the rear of the home. Recommend repair or replace as necessary.

Long cable "drooping" almost to the ground on the left side of the home. This appears to be a coax cable of some kind. This is a safety hazard as well as an improper installation. Recommend correctly installing cable.

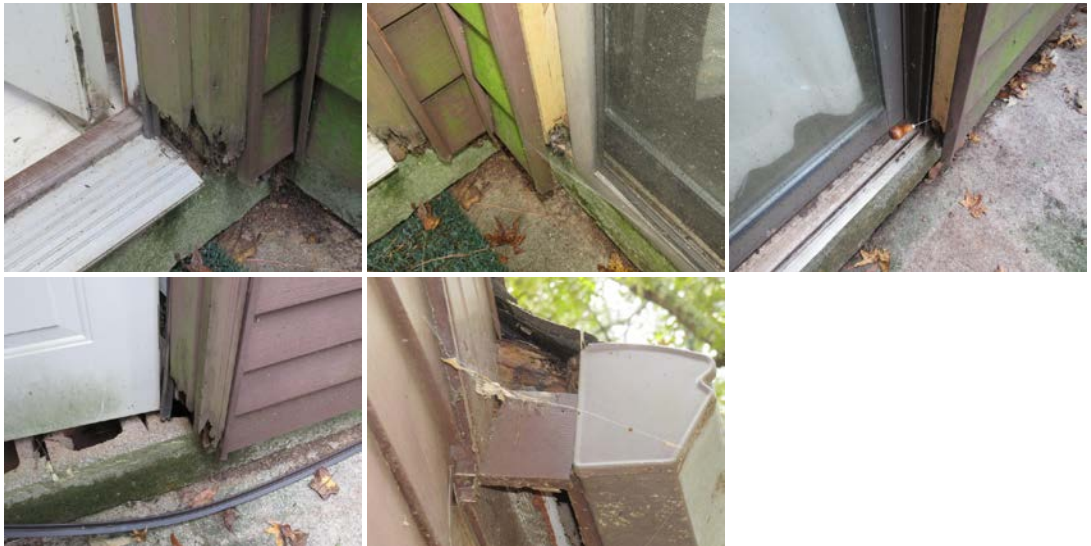
Trim: Aluminum, Wood~ Deterioration noted at various areas where the wood appears to be rotting. Recommend repair or replace as necessary.

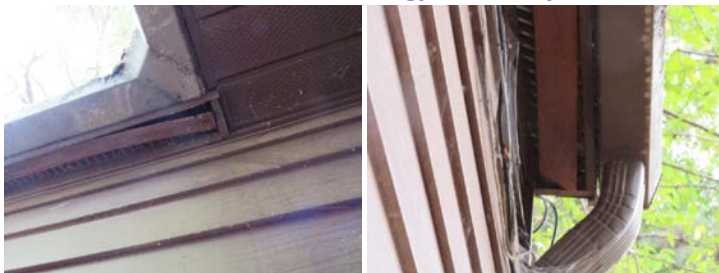
Soffits: Metal~ Rot and rust noted at various areas of soffits. Recommend repair or replace as necessary.

Gaps not properly sealed at various areas. These gaps can allow moisture/pest intrusion to the home, as well as decrease energy efficiency. Recommend properly sealing gaps.

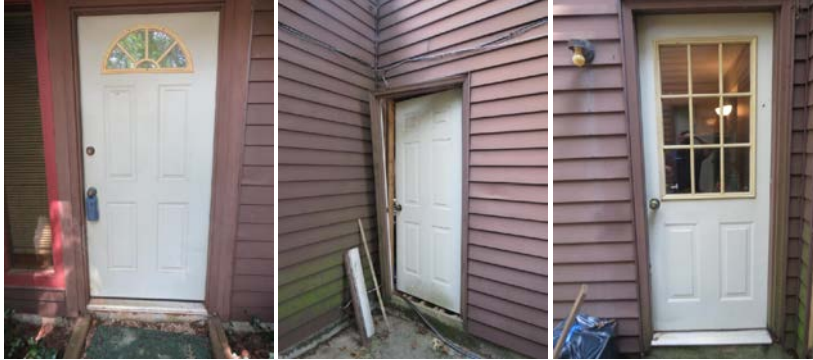
Entry Doors: Wood, Multi pane~ Door frame has rotted loose and separated at the top. A qualified contractor is recommended to evaluate and estimate repairs

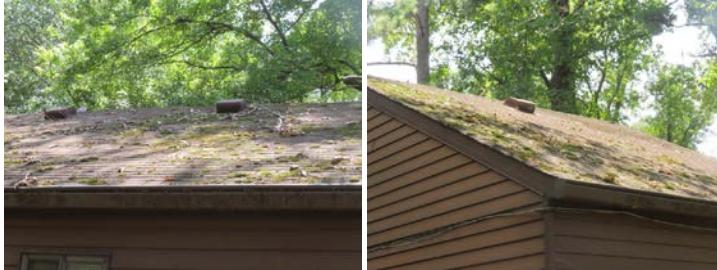
Material: Asphalt shingle~ Recommend clearing all tree limbs, leaves, moss, and algae from roof surface. This will accelerate deterioration of roofing material by retaining moisture causing damage. Roof should be reinspected after clearing to make sure shingles are not deteriorated.

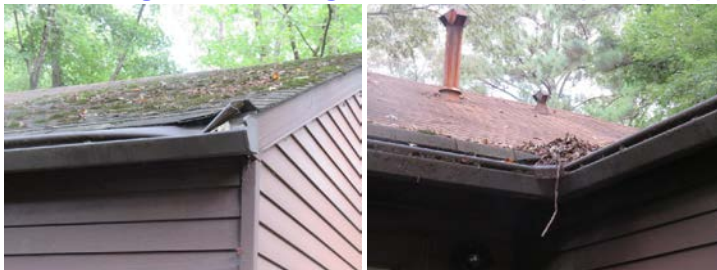
Gutters: Aluminum~ Gutters are full of debris and will inhibit the proper flow of water, recommend cleaning.

Section of gutter is damaged. Recommend repair or replace as necessary.

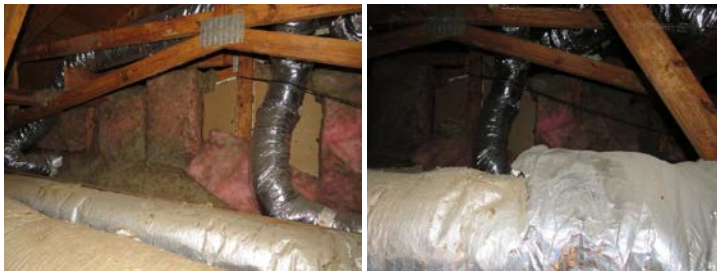
Insulation: Batts, Loose~ **Insulation is discolored and has fallen out of place in several areas. This could possibly be water damage as there were several water spots on the ceilings throughout the house. The spots appeared to be dry at the time of inspection but it is recommended to have a licensed professional further evaluate and estimate repairs.**

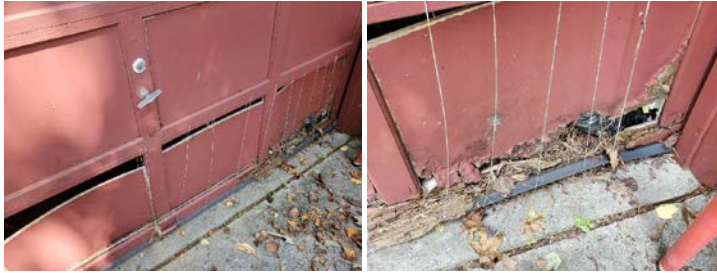
Acceptable	Ceiling: Exposed framing
Acceptable	Walls: Drywall unfinished ~ Tape Coat of Drywall Compound Only
Acceptable	Floor/Foundation: Poured concrete
Major Defect	Garage Doors: Wood~ Deterioration noted at the bottom of the garage door. This garage door will need to be replaced.

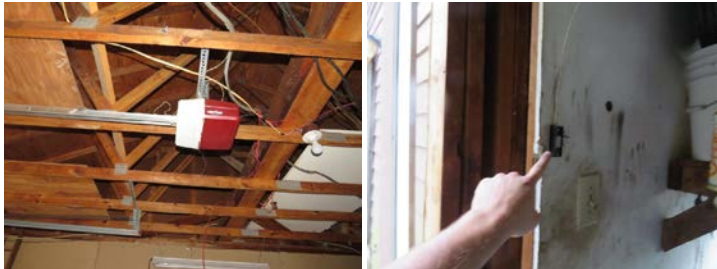
Major Defect	Door Operation: Mechanized~ Garage door not operational at the time of inspection. A qualified contractor is recommended to evaluate and estimate repairs
--------------	--

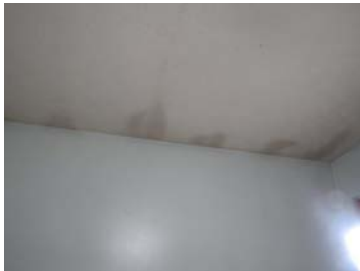
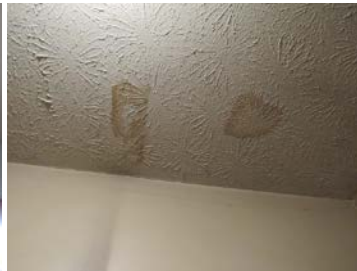
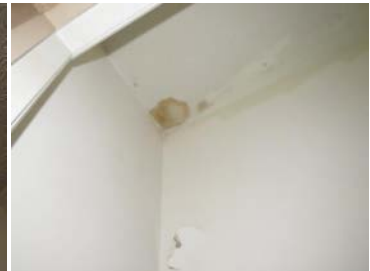
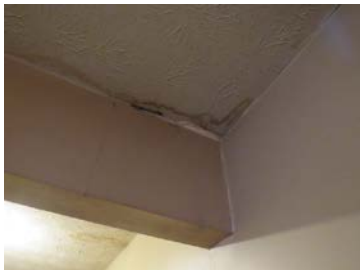
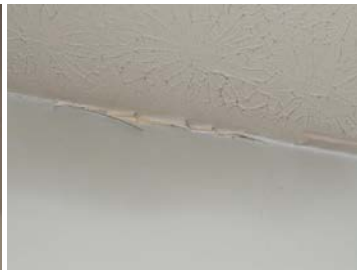
Ceilings: Paint, Texture paint~ Water stains present. These appeared to be dry at the time of inspection. Consult current owner regarding cause and monitor these in the future for leaks. Prime and paint as necessary.

Black marks in area of HVAC registers suggest poor air quality in home. Recommend cleaning air ducts and registers.

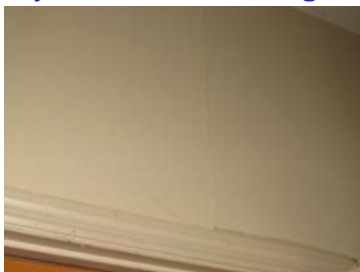
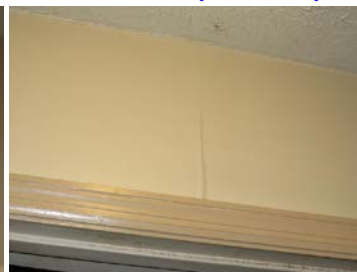
Walls: Paint~ Hairline cracks present on the walls. These are typical and should be sealed.

Drywall has been damaged. Recommend repair or replace as necessary.

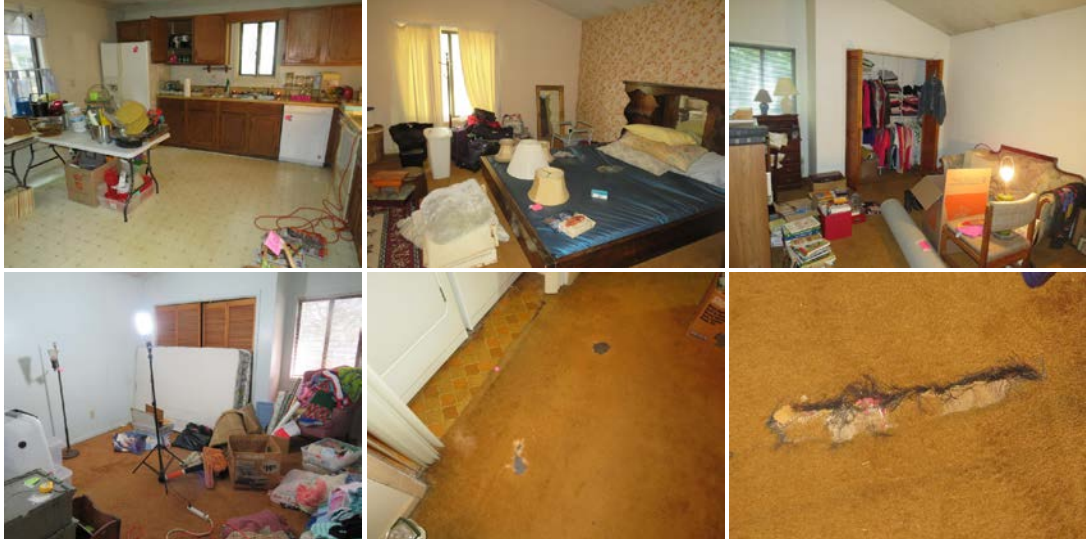
Floors: Tile, Carpet~ Carpet is worn out and torn in several areas. Recommend replacement.

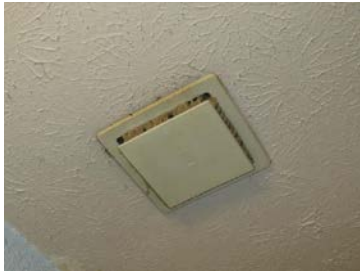
Ventilation: Electric ventilation fan, Window~ Ventilation fan in bathroom has large amounts of dust build up. Recommend cleaning.

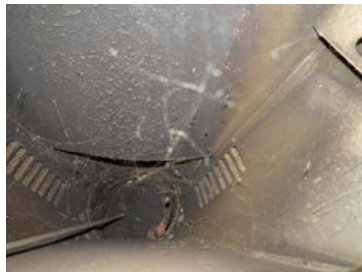
Flue: Metal~ **Deferred maintenance item ~ fireplace has been used and as a result there is some build up of soot in the flue / recommend standard cleaning every year to prevent creosote build up.**

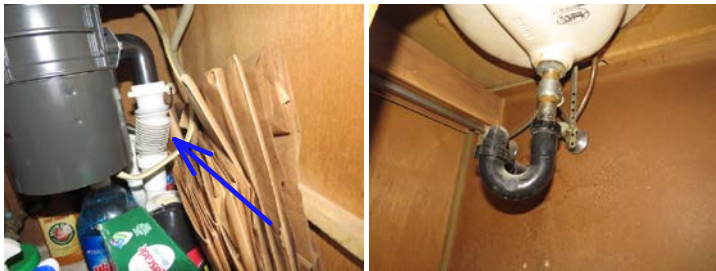
Faucets/Traps: Functioning no leaks observed at the time of inspection~ Flexible "Accordion" drain pipe is in use. This type of piping can trap particles and water and is a good breeding ground for bacteria and foul odors. This should be replaced with smooth PVC drain pipes.

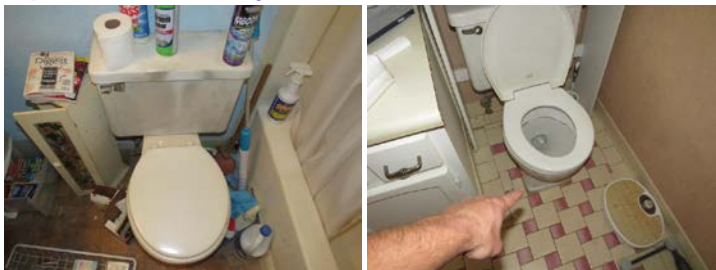
Toilets: Functional at time of inspection no leaks closet bolts secure~ The toilet is loose at the floor and will require tightening of the closet bolts at a minimum. As the toilet is jarred around, it is possible for the wax ring at the base to become damage and leak. Recommend repair or replace as necessary.

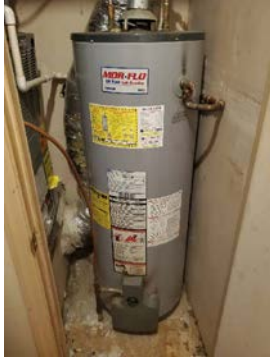
Water Heater Operation: Functional at time of inspection~ **Water heater has exceeded design life. Although it was functional at the time of inspection, recommend budgeting for its replacement in the near future.**

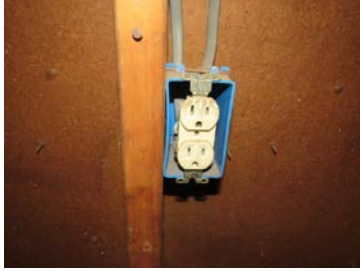
120 VAC Branch Circuits: Copper~ **Covers are missing from outlets/wall switches in various areas. Recommend correcting as this is a safety hazard.**

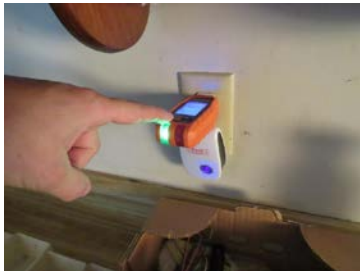
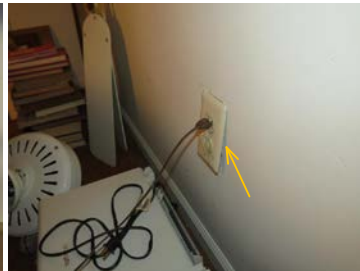
120 Vac Outlets: 110 VAC~ Non-GFCI circuit in kitchen and bathrooms - consider a safety upgrade by installing a GFCI circuit /outlet.

Outlet loose at the wall. This can cause wires to be jarred around and ware out prematurely. Recommend securing.

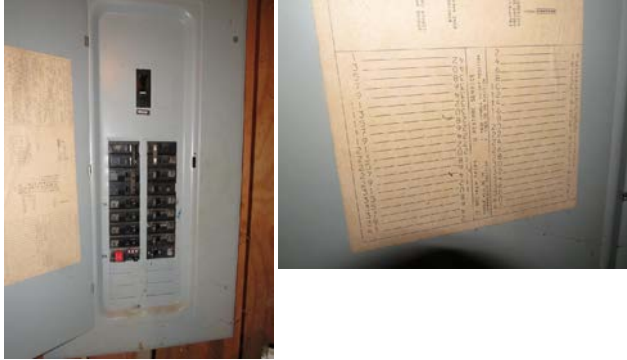
Manufacturer: General Electric~ Legend for breakers is not labeled completely , recommend electrician trace circuits and label panel correctly.

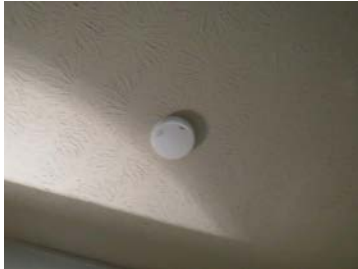
Smoke Detectors: Hard wired~ Current standards recommend smoke detectors be installed any room with a fireplace on all floors, outside sleeping areas, and in all bedrooms.
