Inspection Report

Prepared for~Jennifer & James Thomas

4893 Arcado Rd SW
Lilburn, GA 30047

DS Murphy Inspections

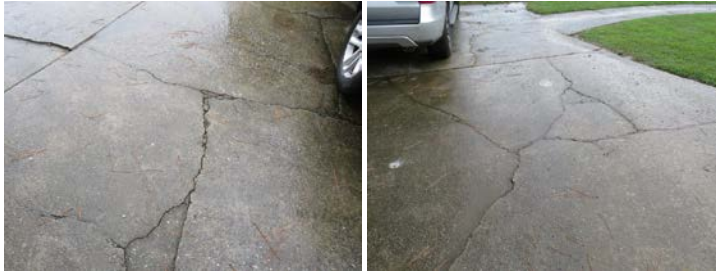
Driveway: Concrete~ Cracks in concrete typical for the age of property. Recommend sealing.

1. Driveway: Concrete~ Cracks in concrete typical for the age of property. Recommend sealing.
2. Deck: Treated wood~ Peeling paint noted on various areas of deck posts and railings. Recommend repair as necessary to protect wood from outside weather.

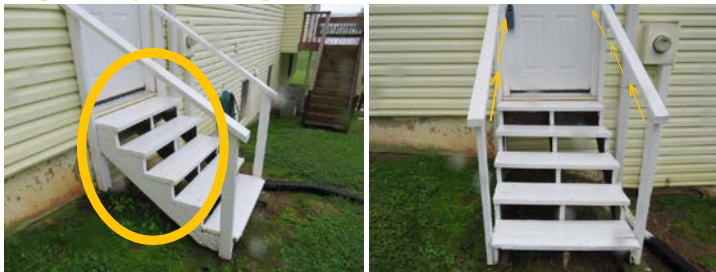
Steps: Wood~ Hand rails have improper baluster spacing. Balusters should be spaced no farther than four (4) inches apart for safety reasons. At the time of construction this may have been an acceptable building practice, but recommend upgrading for safety.

Current safety standards require graspable handrails on any stairs that have more than a 30" drop. This may have been an acceptable building practice at the time of construction, but consider a safety upgrade.

Current standards call for stair risers to be enclosed. This is a safety hazard consider a safety upgrade by enclosing.

1. **Steps: Wood~** Hand rails have improper baluster spacing. Balusters should be spaced no farther than four (4) inches apart for safety reasons. At the time of construction this may have been an acceptable building practice, but recommend upgrading for safety.

Current safety standards require graspable handrails on any stairs that have more than a 30" drop. This may have been an acceptable building practice at the time of construction, but consider a safety upgrade.

Current standards call for stair risers to be enclosed. This is a safety hazard consider a safety upgrade by enclosing.

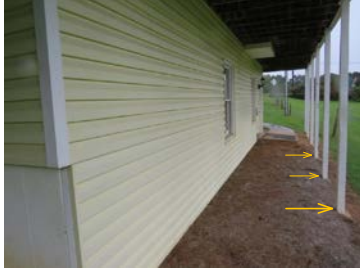
Deck: Treated wood~ Wrap around deck posts are 4x4. This size post was acceptable at the time of construction but current standards call for 6x6 post. Recommend upgrade for improved safety and longevity of deck posts.

2. **Deck: Treated wood~** Wrap around deck posts are 4x4. This size post was acceptable at the time of construction but current standards call for 6x6 post. Recommend upgrade for improved safety and longevity of deck posts.

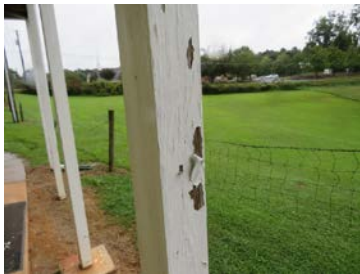
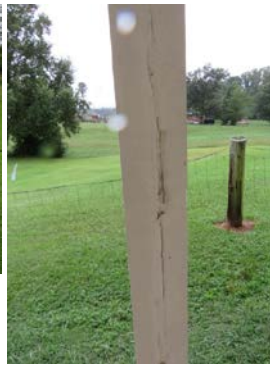
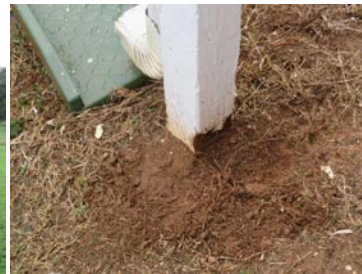
Deck: Treated wood~ **Peeling paint noted on various areas of deck posts and railings. Recommend repair as necessary to protect wood from outside weather.**

Minor wood rot noted in areas where wood is in contact with the ground. The footers are buried in a couple areas. Recommend clearing dirt away to avoid accelerating the deterioration of wood.

Minor wood rot noted in areas where wood is in contact with the ground. The footers are buried in a couple areas. Recommend clearing dirt away to avoid accelerating the deterioration of wood.

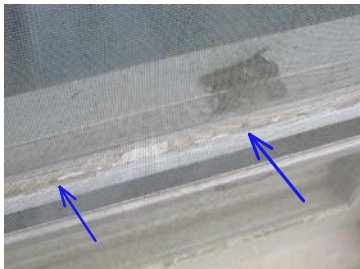
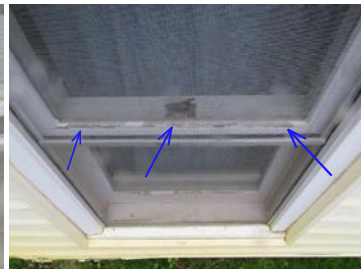
Windows: Wood double hung~ **Some raw unpainted wood noted on exterior of several windows. Priming and painting recommend to protect the wood from moisture.**

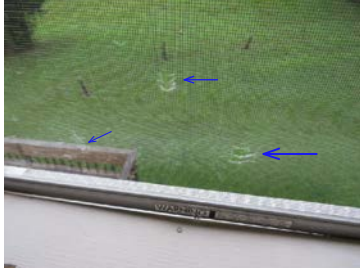
Window Screens: Vinyl mesh~ Several window screens are damaged or missing at various areas. Recommend repair or replace as necessary.

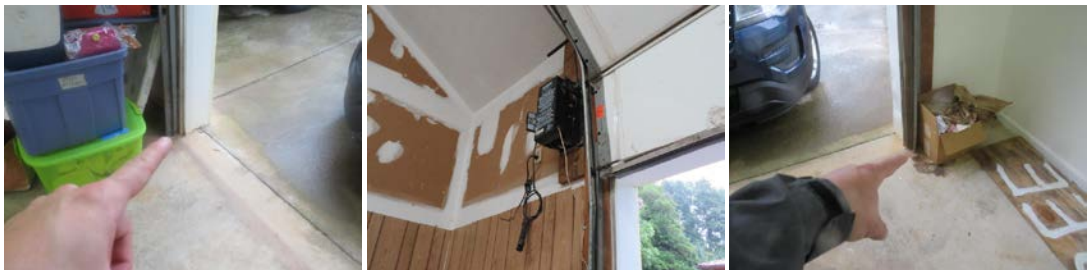
Door Operation: Mechanized~ Down force adjustments are necessary. This is a safety hazard. There should be an auto reverse should the door hit something on the way down, "Down Force" safety reverse did not function adjust setting on back of the motor head as necessary.

Photoelectric eye beams missing on garage doors. This is a safety hazard as the doors will not stop if someone walks under it during operation.

3. **Door Operation: Mechanized~** Down force adjustments are necessary. This is a safety hazard. There should be an auto reverse should the door hit something on the way down, "Down Force" safety reverse did not function adjust setting on back of the motor head as necessary.

Photoelectric eye beams missing on garage doors. This is a safety hazard as the doors will not stop if someone walks under it during operation.

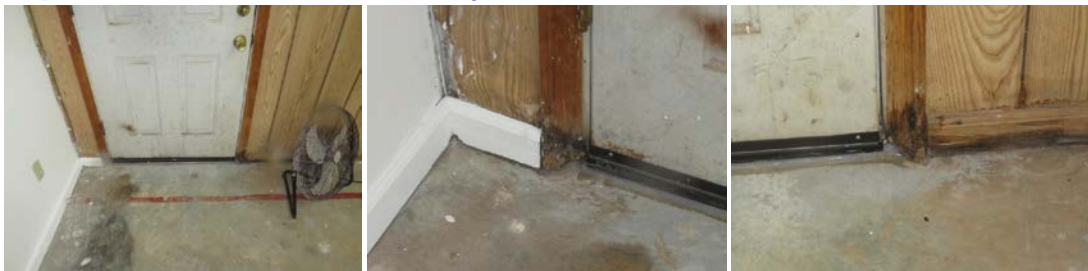
Service Doors: Metal~ Wood rot noted at bottom of door frame on the side entry door in garage. The leaking in this area appeared to have been fixed as it was raining during the entire inspection and this area remained dry.

6. Service Doors: Metal~ Wood rot noted at bottom of door frame on the side entry door in garage. The leaking in this area appeared to have been fixed as it was raining during the entire inspection and this area remained dry.

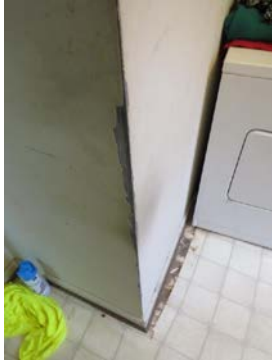
Walls: Paint, Paneling~ Drywall/paint has been damaged. Recommend repair or replace as necessary.

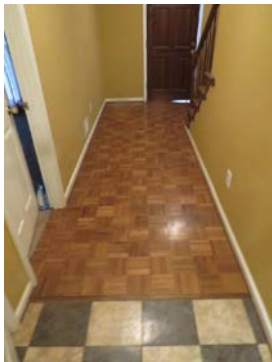
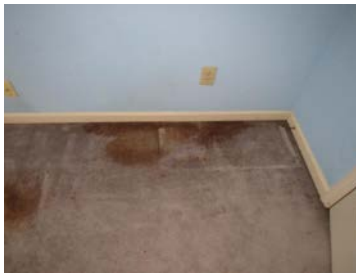
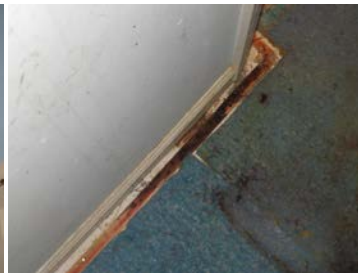
Floors: Tile, Vinyl floor covering, Hardwood, Carpet~ Several deep carpet stains present throughout the home. No real way to determine if the sub floor underneath is damaged without pulling carpet back and inspecting. Recommend replacing carpet/flooring and re-evaluating the condition of the floor underneath.

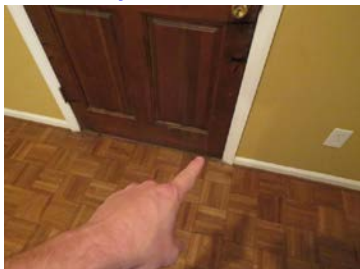
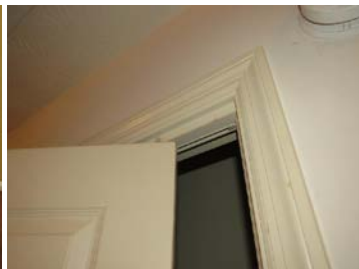
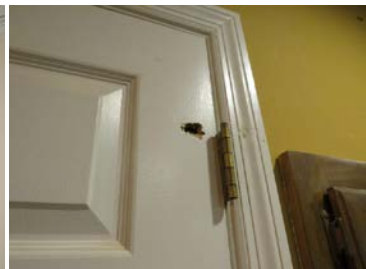
Doors: Hollow wood~ The front door sticks at bottom, adjustments are necessary.

Damage noted to door in kitchen. Repair replace as necessary.

Upstairs Bi-fold closet door has come loose from track. Recommend repair or replace as necessary.

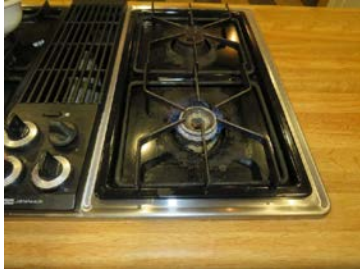
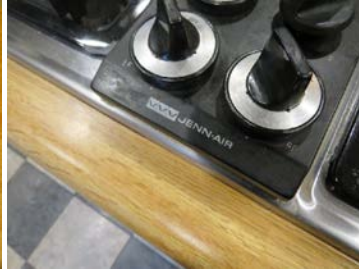
Cooking Appliances: Jenn-Air~ Could only get one burner to ignite. It appeared that the control knobs were stuck. Recommend repair or replace as necessary.

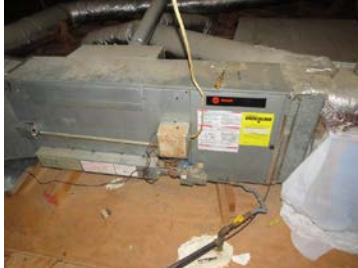
Heating System Operation: Functional at the time of inspection~ **Furnace existing beyond design life. Recommend service inspection and cleaning by HVAC Tech every year.**

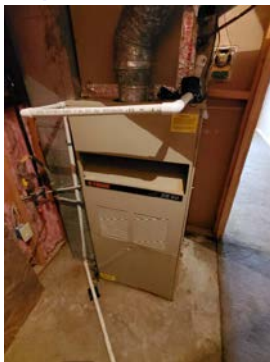
Heating System Operation: Functional at the time of inspection~ **Furnace existing beyond design life. The furnace in the basement was making lots of noise. Recommend service inspection and cleaning by HVAC Tech every year.**

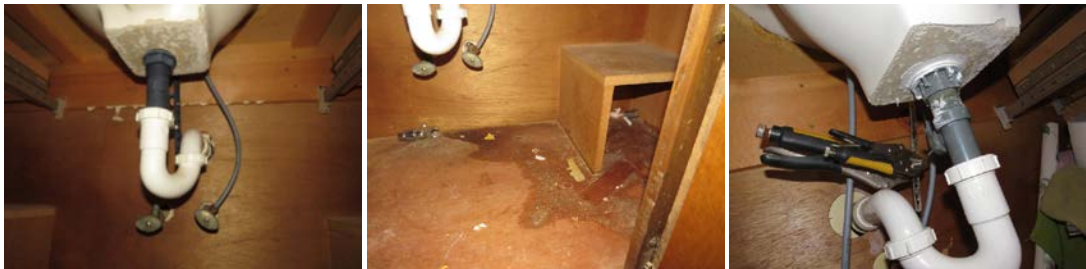
Faucets/Traps: Functioning no leaks observed at the time of inspection~ Signs of possible previous leak under upstairs hall bathroom sink. Did not appear to still be leaking when testing sink drainage or water. Recommend future monitoring.

Drain stopper does not function properly in downstairs bathroom. It appears to be held in place with vice grip pliers. Recommend repair or replace as necessary.

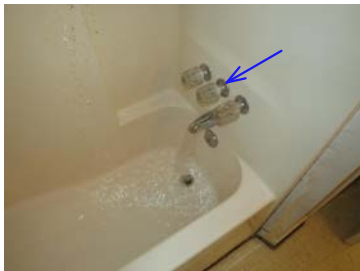
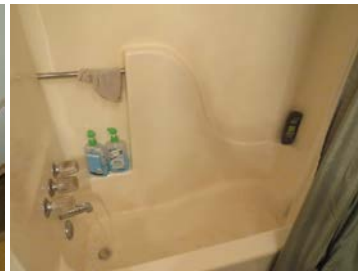
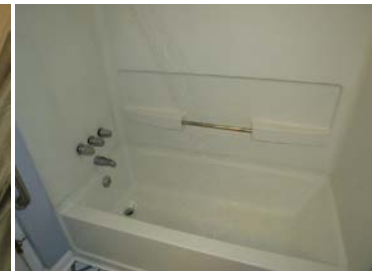
Tub/Surround: Fiberglass tub and fiberglass surround~ Shower diverter in upstairs hall bath not functioning properly. Shower head is not receiving all the water, and pressure is not as desired. Recommend repair or replace as necessary.

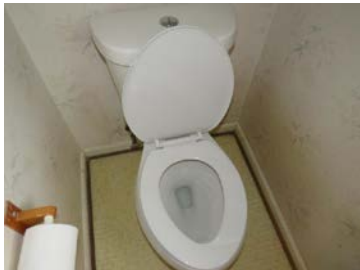
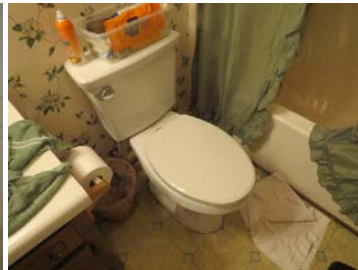
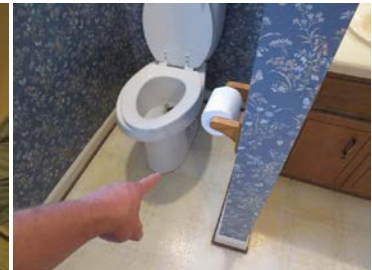
Toilets: Functional at time of inspection no leaks closet bolts secure~ The toilet is loose at the floor and will require tightening of the closet bolts at a minimum. As the toilet is jarred around, it is possible for the wax ring at the base to become damage and leak. Recommend repair or replace as necessary.

Drain stopper does not function properly in downstairs bathroom. It appears to be held in place with vice grip pliers. Recommend repair or replace as necessary.
19. Toilets: Functional at time of inspection no leaks closet bolts secure~ The toilet is loose at the floor and will require tightening of the closet bolts at a minimum. As the toilet is jarred around, it is possible for the wax ring at the base to become damage and leak. Recommend repair or replace as necessary.

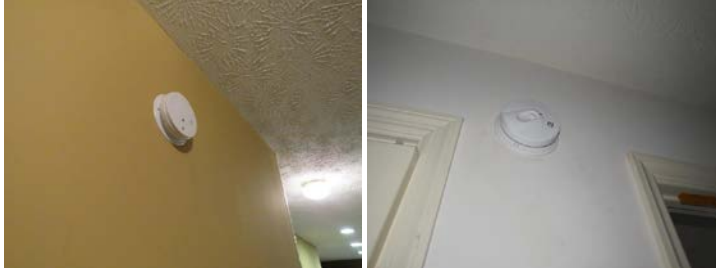
Smoke Detectors: Battery operated with light~ **Current standards recommend smoke detectors be installed any room with a fireplace on all floors, outside sleeping areas, and in all bedrooms.**

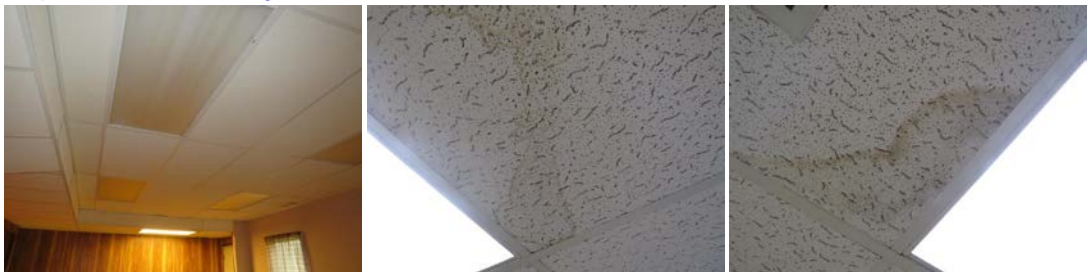
Ceiling: Suspended ceiling, Exposed framing~ **Water stains present. These were dry at the time of inspection. Consult current owner regarding cause and monitor these in the future for leaks. Replace as necessary.**

20. Ceiling: Suspended ceiling, Exposed framing~ Water stains present. These were dry at the time of inspection. Consult current owner regarding cause and monitor these in the future for leaks. Replace as necessary.

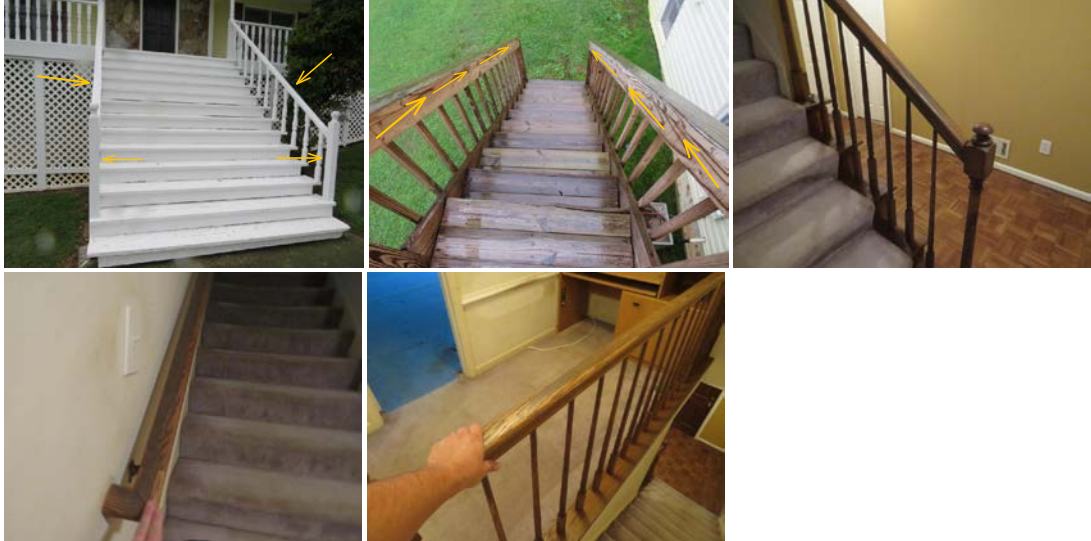
Safety Hazard Railings: Loose~ The railings/posts are loose on all inside and outside railings, the 2000 IRC (IRC Table R301.5) and other typical building codes requires that a guardrail or a handrail be able to resist a 200-pound concentrated load applied along the top in any direction, while some local codes may still be in effect specify a smaller load of 20 pounds per linear foot.

Outside railings are missing a graspable handrail. This may have been acceptable at the time of construction. Consider a safety upgrade.

7. Railings: Loose~ The railings/posts are loose on all inside and outside railings, the 2000 IRC (IRC Table R301.5) and other typical building codes requires that a guardrail or a handrail be able to resist a 200-pound concentrated load applied along the top in any direction, while some local codes may still be in effect specify a smaller load of 20 pounds per linear foot.

Outside railings are missing a graspable handrail. This may have been acceptable at the time of construction. Consider a safety upgrade.
