DS Murphy Inspections  
Suwannee, GA 30024  
678 573 6005

# Inspection Report

**6105 Lynwood Dr  
Forest Park, Ga 30279**

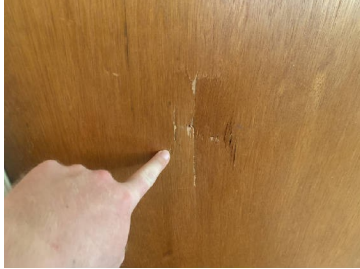
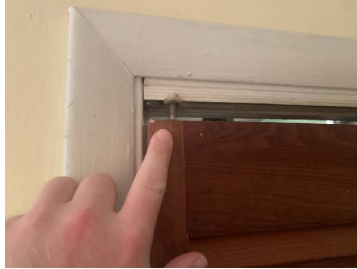
Doors: Hollow wood~ Mechanical room door had a hole in it and the other entry door to the mechanical room was off of the slider. Also the bedroom closet sliding door would not fully close. Recommend remediation as necessary.

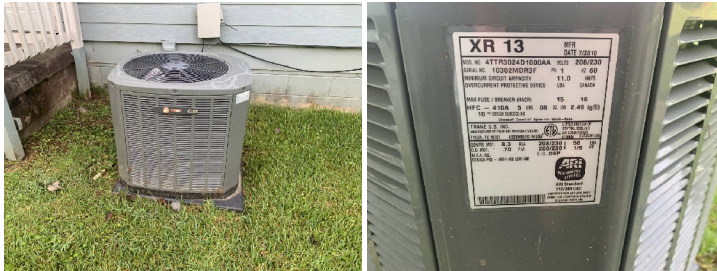
A/C System Operation: Functional~ While it was manufactured in 2010, the AC unit operates on the newer R410A refrigerant and functioned appropriately at the time of the inspection.
