DS Murphy Inspections
Suwannee, GA 30024
678 573 6005

Inspection Report

**3144 Flamingo Drive
Atlanta, GA 30344**

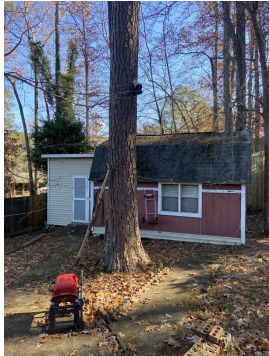
Minor Defect Walks: Wood~ OSB board installed for ramp leading up to the white outbuilding which material is not designed for outdoor use due to rotting.
Recommend replacing with pressure treated plywood.

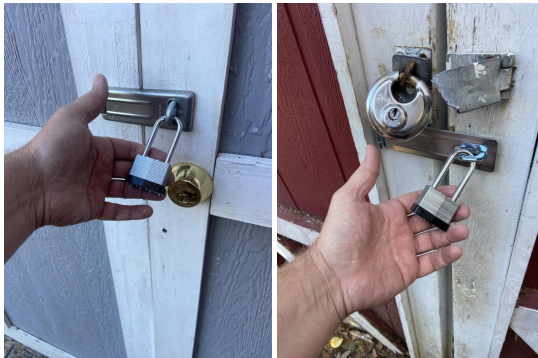
Walls: Was not able to gain access to the inside of the outbuildings.
Interior of outbuildings not inspected.

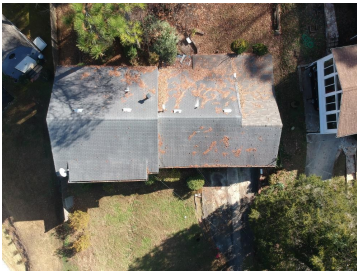
The roof was inspected remotely using a drone with camera attached.

Unable to Inspect: 20%~ Visual Inspection by Drone only.

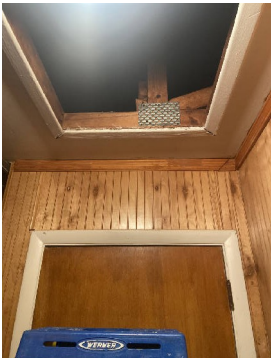
Unable to Inspect: 70%~ Safety /no sheathing / footing present.

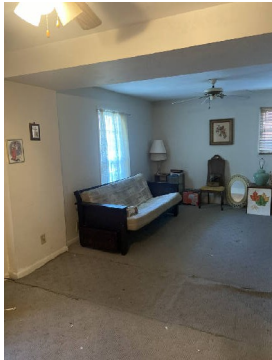
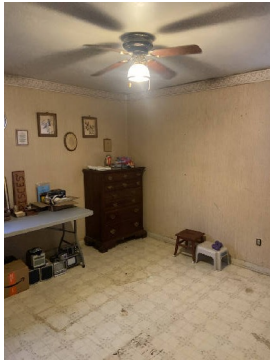
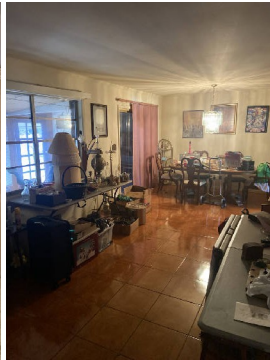
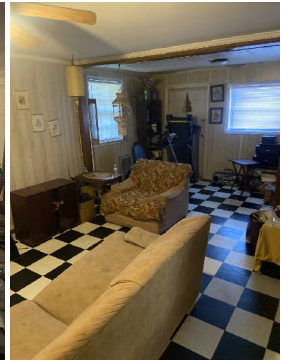
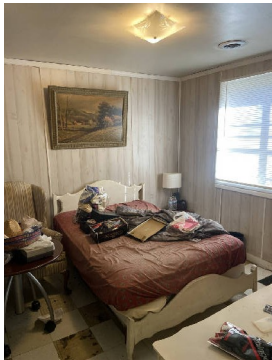
Floors: Carpet, Tile, Vinyl floor covering, Laminate~ **1) Loose carpet is creating a trip hazard. Recommend stretching carpet.**
2) Pulled up vinyl floor covering in back bedroom in front of bathroom door is creating a trip hazard.

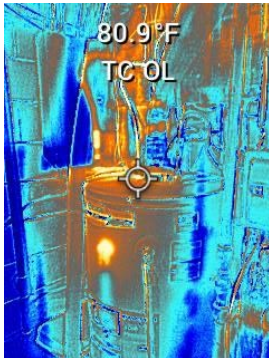
Water Heater Operation: Adequate~ **Hot water heater is only four years old and has many more years of service.**
