Inspection Report

Prepared for~Jennifer & James Thomas

4883 Arcado Rd SW
Lilburn, GA 30047

DS Murphy Inspections

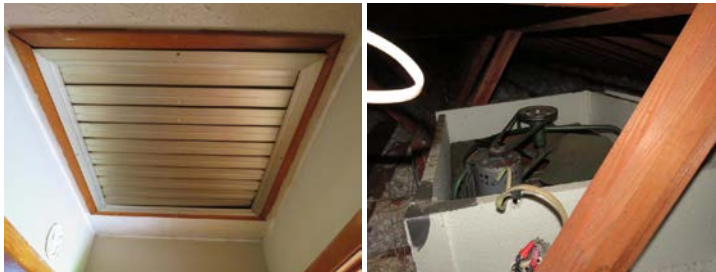
Insulation Depth: 13"
Attic Fan: Belt drive

Wiring/Lighting: 110 VAC lighting circuit
Pest Activity: None noted at the time of inspection. **Empty trap noted in attic. No visible signs of pest activity.**

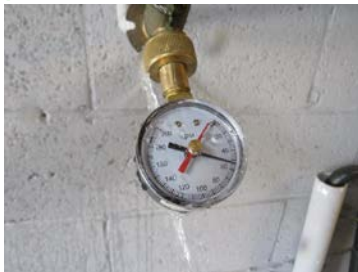
Service Line: Copper~ Household water pressure noted at @ 55 PSI . Typically household pressure should be between 40 and 80 PSI.

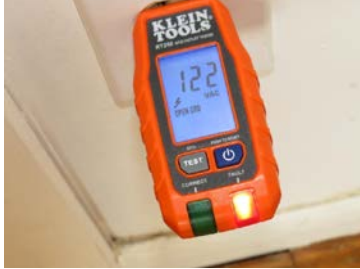
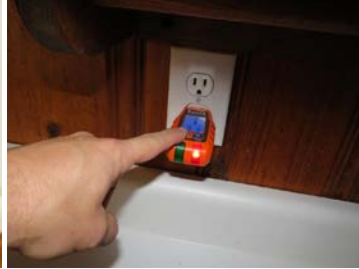
120 Vac Outlets: (continued)

120 Vac Outlets: 110 VAC~ Majority of the outlets in the home have an open ground. This is typical for a house this age as a ground was not required when it was built. Without the ground present, errors that occur with your outlet may cause arcing sparks and electrical charge that can spawn fire along walls or on nearby furniture and fixtures.

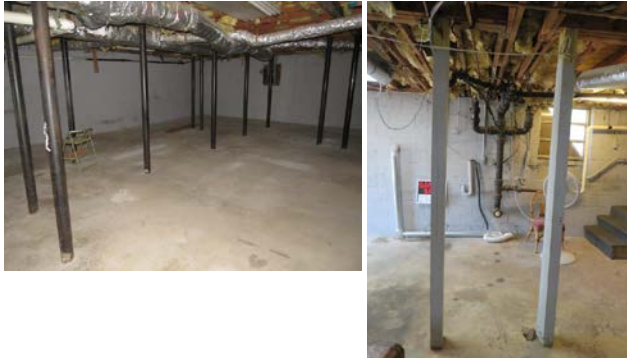
Floor/Slab: Poured slab
Stairs (Interior): Wood stairs with wood handrails~ **Missing return caps at end of handrails. This is a safety hazard as clothing or other items could get caught and cause a fall. Consider a safety upgrade by installing return caps at top and bottom of railings.**

Hand rails have improper baluster spacing. Balusters should be spaced no farther than four (4) inches apart for safety reasons. At the time of construction this may have been an acceptable building practice, but recommend upgrading for safety.
