DS Murphy Inspections  
Suwannee, GA 30024  
678 573 6005

# Inspection Report

**405 County Line Rd  
Fayetteville, Ga 30215**

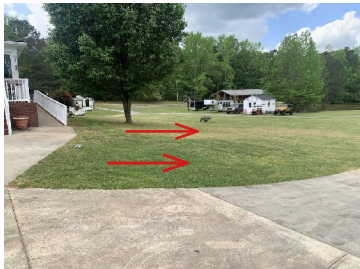
Grading: Moderate slope~ Grading was more than sufficient to direct water flow away from the homes foundation.

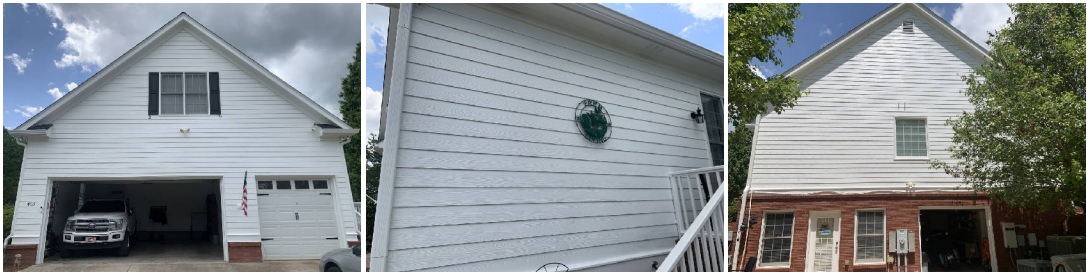
Type: Cement Fiber Siding, Brick veneer~ Siding on the home was recently painted as per the home owner.

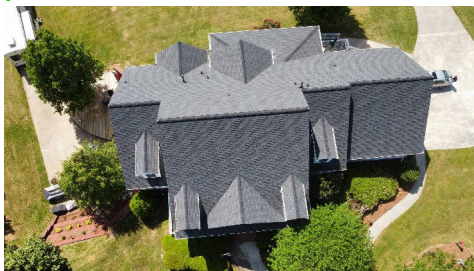
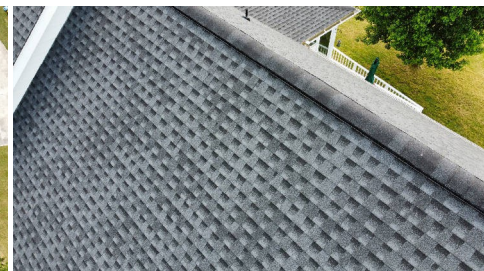
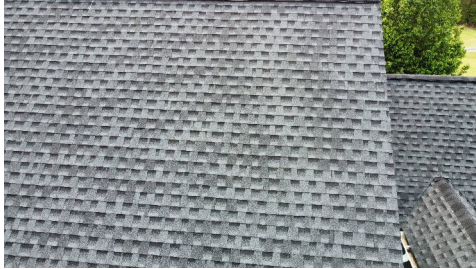
Material: Asphalt shingle~ Roof was in good condition and was replaced in December 2021 as per the homeowner.

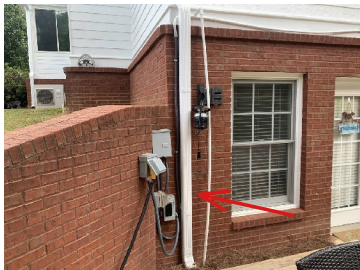
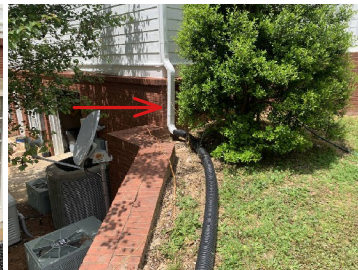
Gutters: Aluminum~ Gutters had little to no debris at the time of the inspection. Recommend continuing routine maintenance at least twice a year.

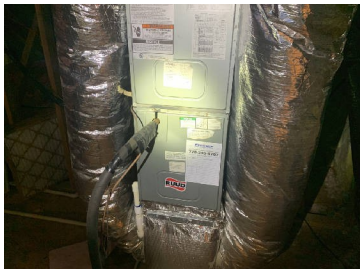
Heating System Operation: Functional at the time of inspection~ **Furnace existing beyond its design life. The furnace still functioned however recommend budgeting for a replacement should one be needed in the future.**
